# Access Compliance Report

## Public Rights-of-Way

### (Curb Ramps)

Intersection ID: 28969	Main Street: HERON_GLEN_DR	Cross Street: KESTRAL_RIDGE_DR	Location: W
ADA ID: DE755816FA77	Ramp Type: BlendTrans1	Initial Pass/Fail: Fail	Overall Compliance: No
Severity Score: 8.75			
Codes/Mitigation Info/Possible Solution		Field Measurements/Component Compliance

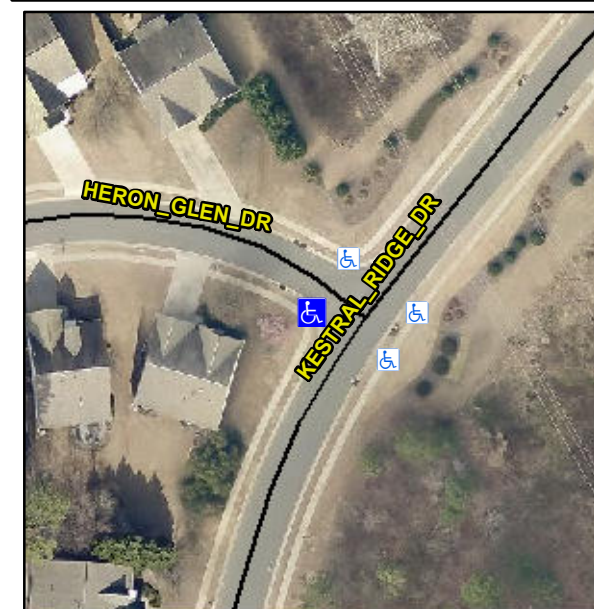
Compliance	Description	Data	Compliance	Description	Data
N/A	Ramp Length (in)	44.0	Yes	BlendTrans Slope (%)	1.7
No	Ramp Width (in)	47.0	Yes	BlendTrans XSlope (%)	0.1
N/A	Flare Type LT	N/A	N/A	Flare Type RT	N/A
N/A	Flare Slope LT (%)	N/A	N/A	Flare Slope RT (%)	N/A
N/A	Flare Traversable LT?	N/A	N/A	Flare Traversable RT?	N/A
N/A	Landing Length (in)	N/A	N/A	DWS Provided?	N/A
N/A	Landing Width (in)	N/A	N/A	DWS Contrast?	N/A
N/A	Landing Slope (%)	N/A	N/A	DWS Length (in)	N/A
N/A	Landing X Slope (%)	N/A	N/A	DWS Full Width?	N/A
N/A	Landing Curb? (Y/N)	N/A	N/A	DWS Offset (in)	N/A
N/A	Shared Landing?	N/A			
N/A	Gutter Ponding?	N/A	N/A	Gutter Slope (%)	N/A
N/A	Gutter Lip Ht (in)	N/A	N/A	Gutter X Slope (%)	N/A
N/A	Painted X Walk1?	No	N/A	Painted X Walk2?	No
	X Walk 1 Direction	To SE		X Walk 2 Direction	To NE
	X Walk 1 Width (in)	N/A		X Walk 2 Width (in)	N/A
	X Walk 1 Slope (%)	1.4		X Walk 2 Slope (%)	2.4
	X Walk 1 X Slope (%)	2.0		X Walk 2 X Slope (%)	1.7

N/A	Ramp inside XWalk1?	N/A	N/A	Ramp inside XWalk2?	N/A
	Road Slope (%)	0.6		Clear Space?	N/A
	Road X Slope (%)	1.6	N/A	Clear Space to XWalk (in)	N/A
N/A	Any Obstructions?	N/A	N/A	Storm Grate/Utility Hazard?	N/A
	Obstruction Type			Storm Grate/Utility Type	
		N/A			N/A
			Yes	Surface Condition? (G/P)	Good
			N/A	Curb Slope (%)	3.8

**Remove & Replace Curb Ramp With Two New Directional Ramps or Equivalent.**

**R304.5.1**

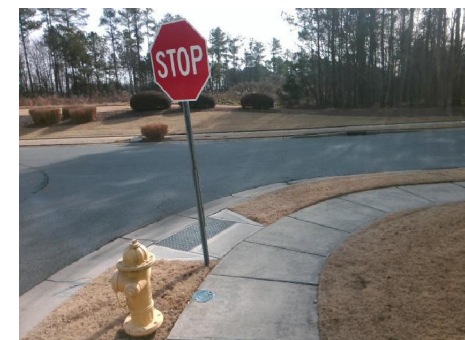
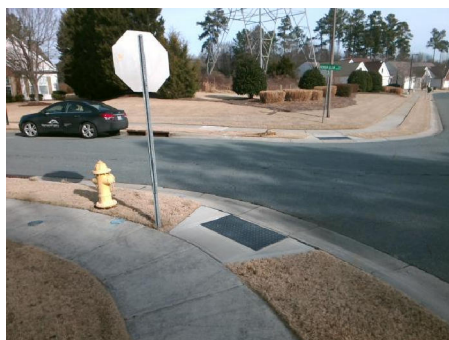
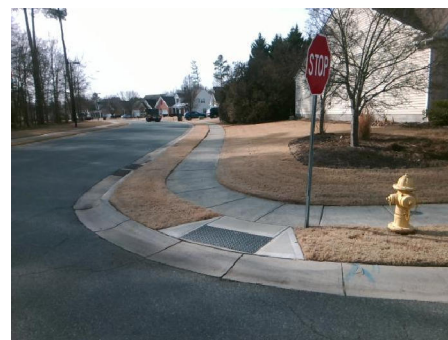
Street 1 Name **KESTRAL RIDGE DR**

Stop Condition-Street 1 **None**

Street 2 Name **HERON GLEN DR**

Stop Condition-Street 2 **StopSign**
