# Access Compliance Report

## Public Rights-of-Way

### (Curb Ramps)

Intersection ID: 13002	Main Street: CENTRAL_AV	Cross Street: PIEDMONT_ST	Location: NE
ADA ID: DE9CF09B0743	Ramp Type: BlendTrans1	Initial Pass/Fail: Fail	Overall Compliance: No
		Severity Score: 1.25

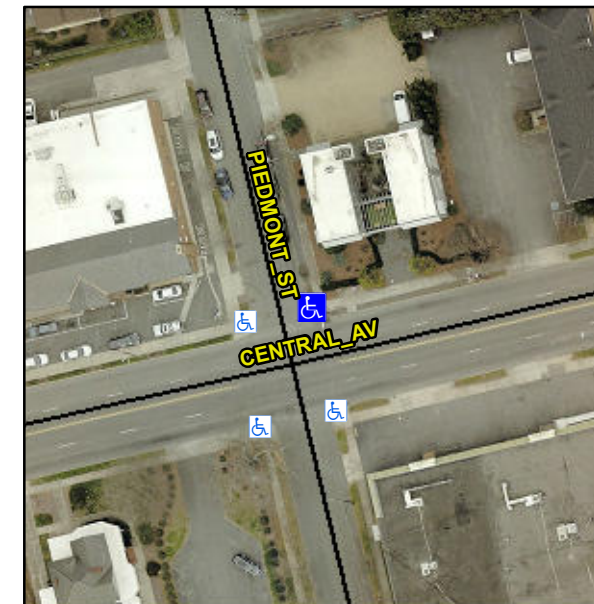
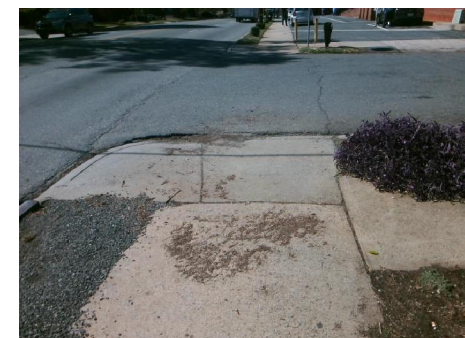
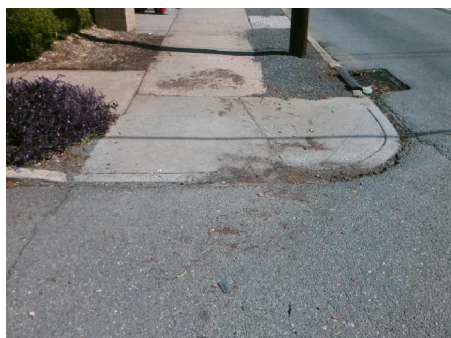
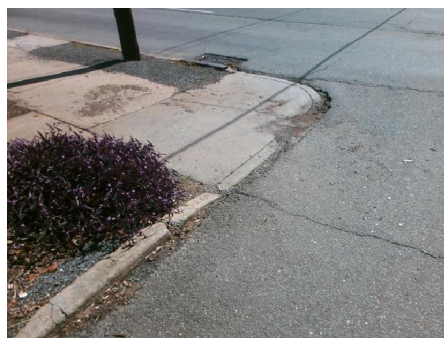
**RP SL < 5%**

**R304.5.3**

Compliance	Description	Data	Compliance	Description	Data
N/A	Ramp Length (in)	71.0	Yes	BlendTrans Slope (%)	1.3
Yes	Ramp Width (in)	80.0	No	BlendTrans XSlope (%)	4.1
N/A	Flare Type LT	N/A	N/A	Flare Type RT	N/A
N/A	Flare Slope LT (%)	N/A	N/A	Flare Slope RT (%)	N/A
N/A	Flare Traversable LT?	N/A	N/A	Flare Traversable RT?	N/A
N/A	Landing Length (in)	N/A	N/A	DWS Provided?	N/A
N/A	Landing Width (in)	N/A	N/A	DWS Contrast?	N/A
N/A	Landing Slope (%)	N/A	N/A	DWS Length (in)	N/A
N/A	Landing X Slope (%)	N/A	N/A	DWS Full Width?	N/A
N/A	Landing Curb? (Y/N)	N/A	N/A	DWS Offset (in)	N/A
N/A	Shared Landing?	N/A			
N/A	Gutter Ponding?	N/A	N/A	Gutter Slope (%)	N/A
N/A	Gutter Lip Ht (in)	1.5	N/A	Gutter X Slope (%)	N/A
N/A	Painted X Walk1?	No	N/A	Painted X Walk2?	N/A
	X Walk 1 Direction	To S		X Walk 2 Direction	N/A
	X Walk 1 Width (in)	N/A		X Walk 2 Width (in)	N/A
	X Walk 1 Slope (%)	2.7		X Walk 2 Slope (%)	N/A
	X Walk 1 X Slope (%)	0.8		X Walk 2 X Slope (%)	N/A

N/A	Ramp inside XWalk1?	N/A	N/A	Ramp inside XWalk2?	N/A
	Road Slope (%)	0.8		Clear Space?	N/A
	Road X Slope (%)	2.7	N/A	Clear Space to XWalk (in)	N/A
N/A	Any Obstructions?	N/A	N/A	Storm Grate/Utility Hazard?	N/A
	Obstruction Type			Storm Grate/Utility Type	
		N/A			N/A
			Yes	Surface Condition? (G/P)	Good
			N/A	Curb Slope (%)	4.7

**Remove & Replace Curb Ramp With Two New Directional Ramps or Equivalent.**

Total Cost: \$ 3200.00
