Access Compliance Report Public Rights-of-Way (Curb Ramps)

Intersection ID: 46914 Main Street: PONDEROSA PINE LN Cross Street: HARRISBURG RD Location: N **Overall Compliance: No Severity Score:** 10 **ADA ID: DEAACCOBBE60** Ramp Type: BlendTrans1 Initial Pass/Fail: Fail

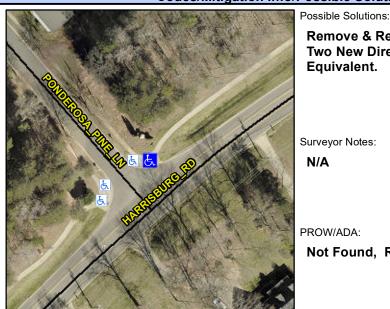
Not Found, R304.5.1, R304.5.3

Compliance Description Data Compliance Description Data Yes BlendTrans Slope (%) N/A Ramp Length (in) 87.0 3.9 47.5 No No Ramp Width (in) BlendTrans XSlope (%) 3.6 N/A Flare Type RT N/A Flare Type LT N/A N/A N/A Flare Slope LT (%) N/A N/A Flare Slope RT (%) N/A N/A Flare Traversable LT? N/A N/A Flare Traversable RT? N/A N/A Landing Length (in) N/A N/A **DWS Provided?** N/A N/A Landing Width (in) N/A N/A **DWS Contrast?** N/A N/A N/A N/A Landing Slope (%) DWS Length (in) N/A N/A Landing X Slope (%) N/A N/A DWS Full Width? N/A N/A Landing Curb? (Y/N) N/A N/A DWS Offset (in) N/A N/A N/A Shared Landing? N/A **Gutter Ponding?** N/A N/A Gutter Slope (%) N/A N/A Gutter Lip Ht (in) N/A N/A Gutter X Slope (%) N/A N/A Painted X Walk1? No N/A Painted X Walk2? N/A X Walk 1 Direction To SE X Walk 2 Direction N/A N/A X Walk 1 Width (in) X Walk 2 Width (in) N/A X Walk 1 Slope (%) 4.7 X Walk 2 Slope (%) N/A X Walk 1 X Slope (%) 2.8 X Walk 2 X Slope (%) N/A N/A N/A Ramp inside XWalk2? N/A Ramp inside XWalk1? N/A Road Slope (%) 2.8 Clear Space? N/A N/A Road X Slope (%) 4.7 Clear Space to XWalk (in) N/A N/A N/A N/A Any Obstructions? Storm Grate/Utility Hazard? N/A **Obstruction Type** Storm Grate/Utility Type N/A N/A Yes Surface Condition? (G/P) Good No Curb Slope (%) 20.0

HARRISBURG RD Street 1 Name Stop Condition-Street 1 None N/A Street 2 Name Stop Condition-Street 2 N/A Remove & Replace Curb Ramp With Two New Directional Ramps or Equivalent.
