Access Compliance Report

Public Rights-of-Way

(Curb Ramps)

Intersection ID: 9373	Main Street: EUREKA_ST	Cross Street: GENESIS_PARK_PL	Location: SW
ADA ID: DEB2197526AE	Ramp Type: Perp	Initial Pass/Fail: Fail	Overall Compliance: No
Severity Score: 21.25			
Codes/Mitigation Info/Possible Solution		Field Measurements/Component Compliance

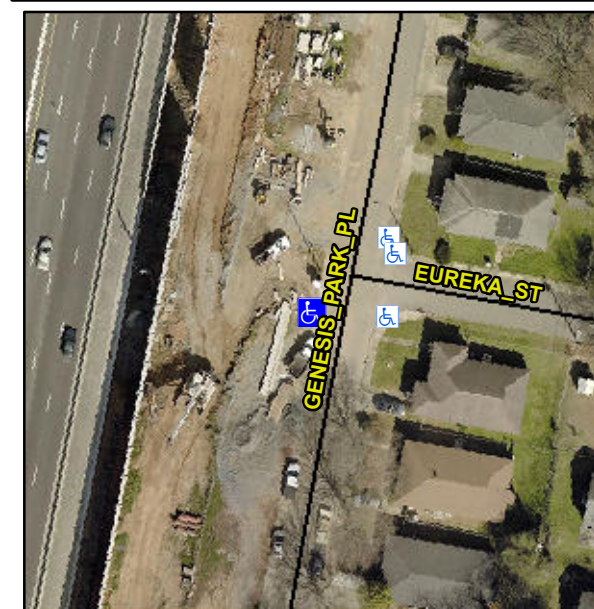
R304.5.1, R304.2.2

Compliance	Description	Data	Compliance	Description	Data
N/A	Ramp Length (in)	55.0	No	Ramp Slope (%)	9.0
No	Ramp Width (in)	46.0	Yes	Ramp XSlope (%)	1.2
N/A	Flare Type LT	N/A	N/A	Flare Type RT	N/A
N/A	Flare Slope LT (%)	N/A	N/A	Flare Slope RT (%)	N/A
N/A	Flare Traversable LT?	N/A	N/A	Flare Traversable RT?	N/A
N/A	Landing Length (in)	N/A	N/A	DWS Provided?	N/A
N/A	Landing Width (in)	N/A	N/A	DWS Contrast?	N/A
N/A	Landing Slope (%)	N/A	N/A	DWS Length (in)	N/A
N/A	Landing X Slope (%)	N/A	N/A	DWS Full Width?	N/A
N/A	Landing Curb? (Y/N)	N/A	N/A	DWS Offset (in)	N/A
N/A	Shared Landing?	N/A			
N/A	Gutter Ponding?	N/A	N/A	Gutter Slope (%)	N/A
N/A	Gutter Lip Ht (in)	0.5	N/A	Gutter X Slope (%)	N/A
N/A	Painted X Walk1?	No	N/A	Painted X Walk2?	N/A
	X Walk 1 Direction	To SE		X Walk 2 Direction	N/A
N/A	X Walk 1 Width (in)	N/A	N/A	X Walk 2 Width (in)	N/A
	X Walk 1 Slope (%)	7.1		X Walk 2 Slope (%)	N/A
	X Walk 1 X Slope (%)	1.7		X Walk 2 X Slope (%)	N/A

Possible Solutions:

Remove & Replace Entire Ramp.
