Intersection ID: 23162	Main Street: SHARON_RD_WEST	Cross Street: SOUTH_BV	Location:	S
ADA ID: DEBA4ED76CA3	Ramp Type: Perp	Initial Pass/Fail: Fail	Overall Compliance: No	Severity Score: 22.5

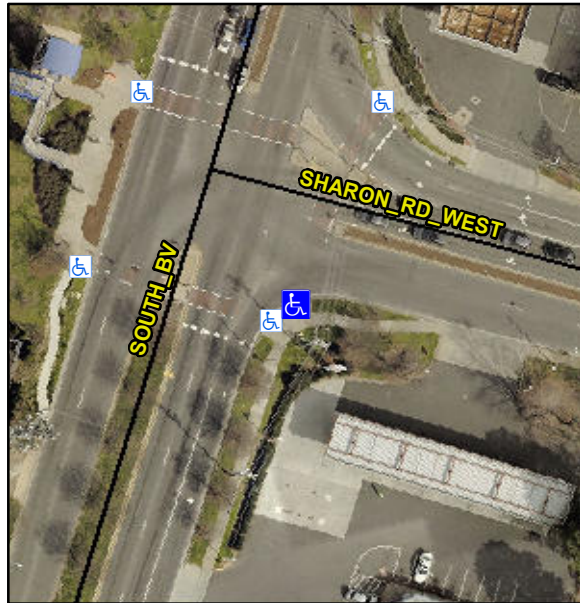
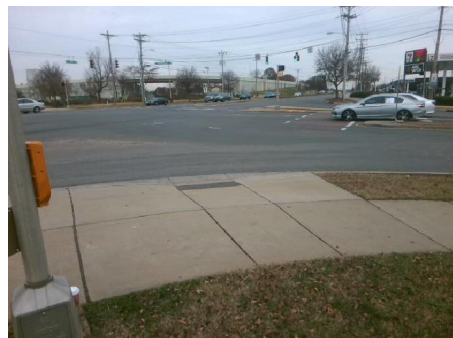
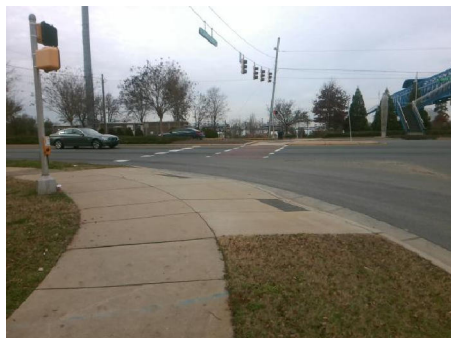
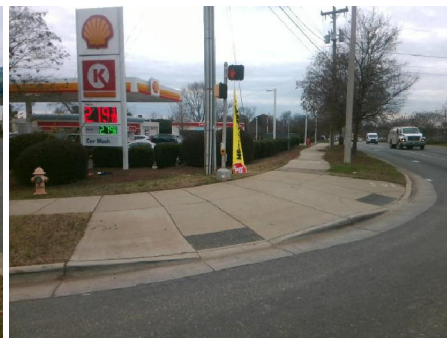
Not Found, R304.5.1, R304.2.2

Possible Solutions:			Compliance	Description	Data	Compliance	Description	Data
Remove & Replace Entire Ramp.			N/A	Ramp Length (in)	95.0	No	Ramp Slope (%)	9.9
			No	Ramp Width (in)	40.0	Yes	Ramp XSlope (%)	3.3
			N/A	Flare Type LT	N/A	N/A	Flare Type RT	N/A
			N/A	Flare Slope LT (%)	N/A	N/A	Flare Slope RT (%)	N/A
			N/A	Flare Traversable LT?	N/A	N/A	Flare Traversable RT?	N/A
			N/A	Landing Length (in)	N/A	N/A	DWS Provided?	N/A
			N/A	Landing Width (in)	N/A	N/A	DWS Contrast?	N/A
			N/A	Landing Slope (%)	N/A	N/A	DWS Length (in)	N/A
			N/A	Landing X Slope (%)	N/A	N/A	DWS Full Width?	N/A
			N/A	Landing Curb? (Y/N)	N/A	N/A	DWS Offset (in)	N/A
Surveyor Notes:			N/A	Shared Landing?	N/A			
Not Found, R304.5.1, R304.2.2			N/A	Gutter Ponding?	N/A	N/A	Gutter Slope (%)	N/A
			N/A	Gutter Lip Ht (in)	N/A	N/A	Gutter X Slope (%)	N/A
			N/A	Painted X Walk1?	No	N/A	Painted X Walk2?	N/A
				X Walk 1 Direction	To NE		X Walk 2 Direction	N/A

N/A	X Walk 1 Width (in)	N/A	N/A	X Walk 2 Width (in)	N/A
				X Walk 1 Slope (%)	0.4		X Walk 2 Slope (%)	N/A
				X Walk 1 X Slope (%)	4.1		X Walk 2 X Slope (%)	N/A
			N/A	Ramp inside XWalk1?	N/A	N/A	Ramp inside XWalk2?	N/A
				Road Slope (%)	N/A	N/A	Clear Space?	N/A
				Road X Slope (%)	N/A	N/A	Clear Space to XWalk (in)	N/A
Total Cost:			\$	1850.00	N/A	N/A	Storm Grate/Utility Hazard?	N/A
				Obstruction Type			Storm Grate/Utility Type	
					N/A			N/A
						Yes	Surface Condition? (G/P)	Good

Remove & Replace Entire Ramp.

Total Cost: \$ 1850.00
