Access Compliance Report

Public Rights-of-Way

(Curb Ramps)

Intersection ID: 11685	Main Street: E_19TH_ST	Cross Street: SEIGLE_AV	Location: SW
ADA ID: DEBB349B8196	Ramp Type: Perp	Initial Pass/Fail: Fail	Overall Compliance: No
Severity Score: 13.75			
Codes/Mitigation Info/Possible Solution		Field Measurements/Component Compliance

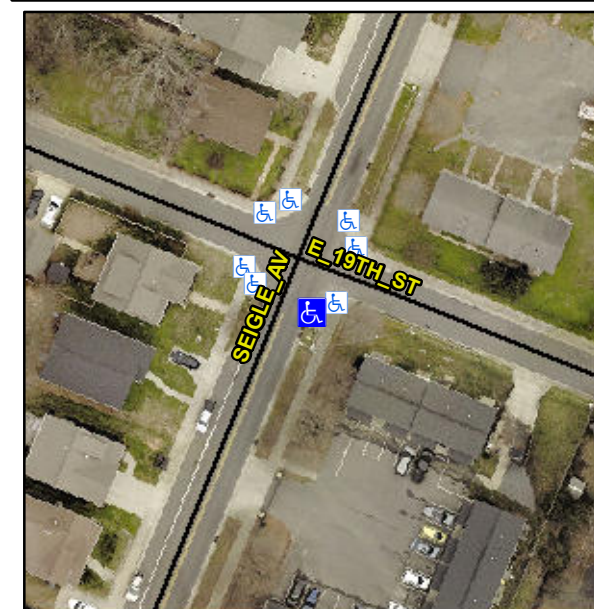
Compliance	Description	Data	Compliance	Description	Data
N/A	Ramp Length (in)	74.0	No	Ramp Slope (%)	8.5
Yes	Ramp Width (in)	48.0	No	Ramp XSlope (%)	4.9
N/A	Flare Type LT	N/A	N/A	Flare Type RT	N/A
N/A	Flare Slope LT (%)	N/A	N/A	Flare Slope RT (%)	N/A
N/A	Flare Traversable LT?	N/A	N/A	Flare Traversable RT?	N/A
N/A	Landing Length (in)	N/A	N/A	DWS Provided?	N/A
N/A	Landing Width (in)	N/A	N/A	DWS Contrast?	N/A
N/A	Landing Slope (%)	N/A	N/A	DWS Length (in)	N/A
N/A	Landing X Slope (%)	N/A	N/A	DWS Full Width?	N/A
N/A	Landing Curb? (Y/N)	N/A	N/A	DWS Offset (in)	N/A
N/A	Shared Landing?	N/A			
N/A	Gutter Ponding?	N/A	N/A	Gutter Slope (%)	N/A
N/A	Gutter Lip Ht (in)	N/A	N/A	Gutter X Slope (%)	N/A
N/A	Painted X Walk1?	No	N/A	Painted X Walk2?	N/A
	X Walk 1 Direction	To NW		X Walk 2 Direction	N/A
N/A	X Walk 1 Width (in)	N/A	N/A	X Walk 2 Width (in)	N/A
	X Walk 1 Slope (%)	2.1		X Walk 2 Slope (%)	N/A
	X Walk 1 X Slope (%)	3.5		X Walk 2 X Slope (%)	N/A

N/A	Ramp inside XWalk1?	N/A	N/A	Ramp inside XWalk2?	N/A
	Road Slope (%)	N/A	N/A	Clear Space?	N/A
	Road X Slope (%)	N/A	N/A	Clear Space to XWalk (in)	N/A
N/A	Any Obstructions?	N/A	N/A	Storm Grate/Utility Hazard?	N/A
	Obstruction Type			Storm Grate/Utility Type	
		N/A			N/A
			Yes	Surface Condition? (G/P)	Good

Possible Solutions:

Remove & Replace Entire Ramp.

Not Found, R304.2.2, R304.5.3
