Access Compliance Report

Public Rights-of-Way

(Curb Ramps)

Intersection ID: N/A	Main Street: S_CALDWELL_ST	Cross Street: E_3RD_ST	Location: SW
ADA ID: DEC12F89896F	Ramp Type: BlendTrans1	Initial Pass/Fail: Fail	Overall Compliance: No
Severity Score: 12.5			
Codes/Mitigation Info/Possible Solution		Field Measurements/Component Compliance

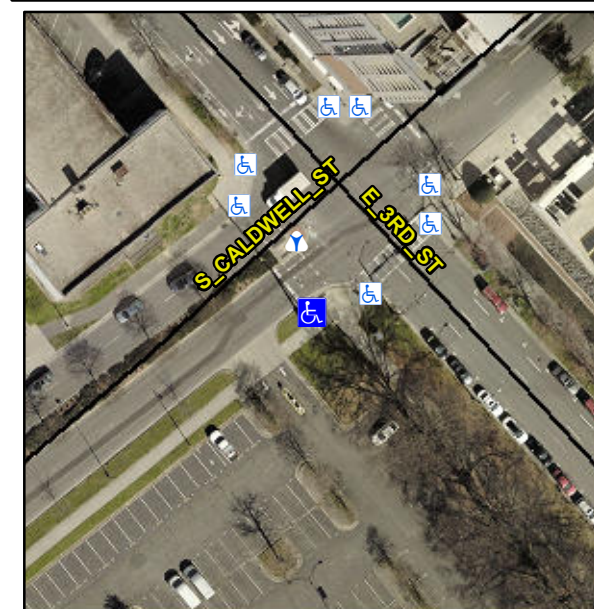
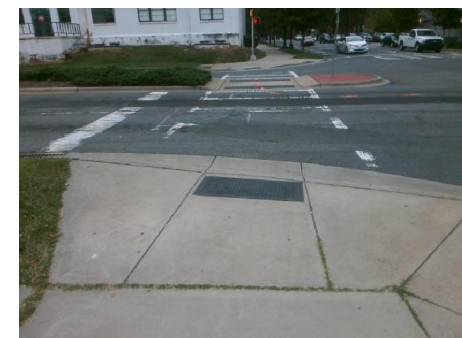
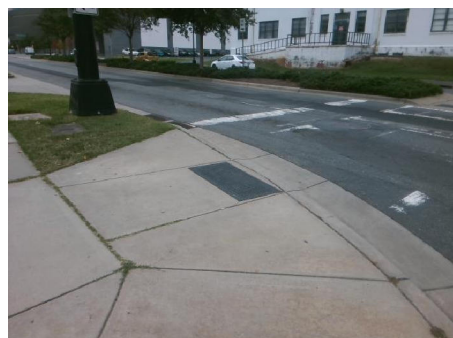
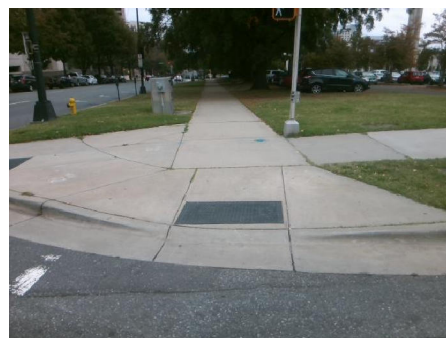
Not Found, R304.5.3

Compliance	Description	Data	Compliance	Description	Data
N/A	Ramp Length (in)	88.0	Yes	BlendTrans Slope (%)	2.4
Yes	Ramp Width (in)	51.0	No	BlendTrans XSlope (%)	5.6
N/A	Flare Type LT	N/A	N/A	Flare Type RT	N/A
N/A	Flare Slope LT (%)	N/A	N/A	Flare Slope RT (%)	N/A
N/A	Flare Traversable LT?	N/A	N/A	Flare Traversable RT?	N/A
N/A	Landing Length (in)	N/A	N/A	DWS Provided?	N/A
N/A	Landing Width (in)	N/A	N/A	DWS Contrast?	N/A
N/A	Landing Slope (%)	N/A	N/A	DWS Length (in)	N/A
N/A	Landing X Slope (%)	N/A	N/A	DWS Full Width?	N/A
N/A	Landing Curb? (Y/N)	N/A	N/A	DWS Offset (in)	N/A
N/A	Shared Landing?	N/A			
N/A	Gutter Ponding?	N/A	N/A	Gutter Slope (%)	N/A
N/A	Gutter Lip Ht (in)	N/A	N/A	Gutter X Slope (%)	N/A
N/A	Painted X Walk1?	Yes	N/A	Painted X Walk2?	N/A
	X Walk 1 Direction	To NW		X Walk 2 Direction	N/A
	X Walk 1 Width (in)	120.0		X Walk 2 Width (in)	N/A
	X Walk 1 Slope (%)	4.5		X Walk 2 Slope (%)	N/A
	X Walk 1 X Slope (%)	4.0		X Walk 2 X Slope (%)	N/A

N/A	Ramp inside XWalk1?	Yes	N/A	Ramp inside XWalk2?	N/A
	Road Slope (%)	4.0		Clear Space?	N/A
	Road X Slope (%)	4.5	N/A	Clear Space to XWalk (in)	N/A
N/A	Any Obstructions?	N/A	N/A	Storm Grate/Utility Hazard?	N/A
	Obstruction Type			Storm Grate/Utility Type	
		N/A			N/A
			Yes	Surface Condition? (G/P)	Good
			No	Curb Slope (%)	17.1

Remove & Replace Curb Ramp With Two New Directional Ramps or Equivalent.
