Intersection ID: 10019678	Main Street: ANDOVER_RD	Cross Street: N/A	Location:	NW
ADA ID: DEC79C9CCCCC	Ramp Type: PerpDiag	Initial Pass/Fail: Fail	Overall Compliance: No	Severity Score: 13.75

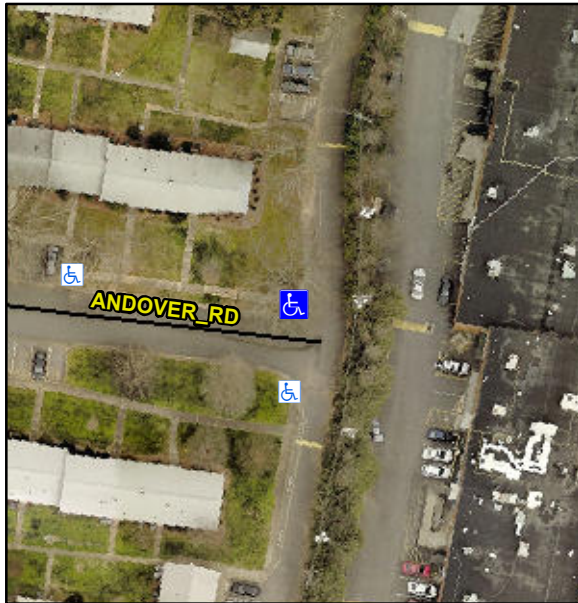
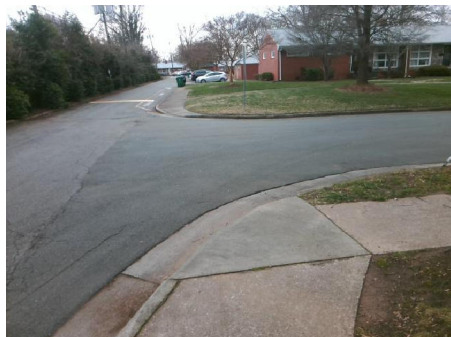
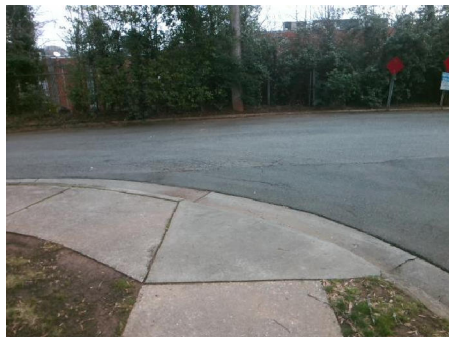
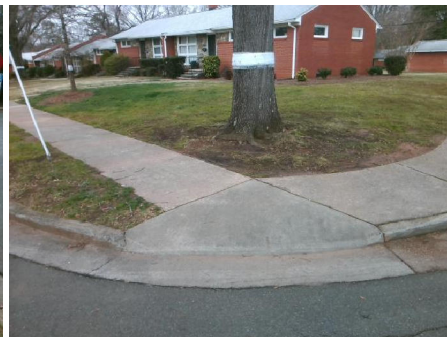
Not Found, R304.2.2, R304.5.3

Compliance	Description	Data	Compliance	Description	Data
N/A	Ramp Length (in)	42.0	No	Ramp Slope (%)	10.2
Yes	Ramp Width (in)	60.0	No	Ramp XSlope (%)	2.7
N/A	Flare Type LT	N/A	N/A	Flare Type RT	N/A
N/A	Flare Slope LT (%)	N/A	N/A	Flare Slope RT (%)	N/A
N/A	Flare Traversable LT?	N/A	N/A	Flare Traversable RT?	N/A
N/A	Landing Length (in)	N/A	N/A	DWS Provided?	N/A
N/A	Landing Width (in)	N/A	N/A	DWS Contrast?	N/A
N/A	Landing Slope (%)	N/A	N/A	DWS Length (in)	N/A
N/A	Landing X Slope (%)	N/A	N/A	DWS Full Width?	N/A
N/A	Landing Curb? (Y/N)	N/A	N/A	DWS Offset (in)	N/A
N/A	Shared Landing?	N/A			
N/A	Gutter Ponding?	N/A	N/A	Gutter Slope (%)	N/A
N/A	Gutter Lip Ht (in)	N/A	N/A	Gutter X Slope (%)	N/A
N/A	Painted X Walk1?	No	N/A	Painted X Walk2?	No
	X Walk 1 Direction	To S		X Walk 2 Direction	To E
N/A	X Walk 1 Width (in)	N/A	N/A	X Walk 2 Width (in)	N/A
	X Walk 1 Slope (%)	2.1		X Walk 2 Slope (%)	2.2
	X Walk 1 X Slope (%)	1.1		X Walk 2 X Slope (%)	0.0

N/A	Ramp inside XWalk1?	N/A	N/A	Ramp inside XWalk2?	N/A
	Road Slope (%)	1.0	N/A	Clear Space?	N/A
	Road X Slope (%)	1.6	N/A	Clear Space to XWalk (in)	N/A
N/A	Any Obstructions?	N/A	N/A	Storm Grate/Utility Hazard?	N/A
	Obstruction Type			Storm Grate/Utility Type	
		N/A			N/A
			Yes	Surface Condition? (G/P)	Good

Remove & Replace Curb Ramp With Two New Directional Ramps or Equivalent.
