Access Compliance Report

Public Rights-of-Way

Intersection ID: 12562	Main Street: PENCE_GROVE_RD	Cross Street: SILVER_CHARM_CT	Location: S
ADA ID: DECAEDF162A2	Ramp Type: Perp	Initial Pass/Fail: Fail	Overall Compliance: No
Severity Score: 8.75			
Codes/Mitigation Info/Possible Solution		Field Measurements/Component Compliance

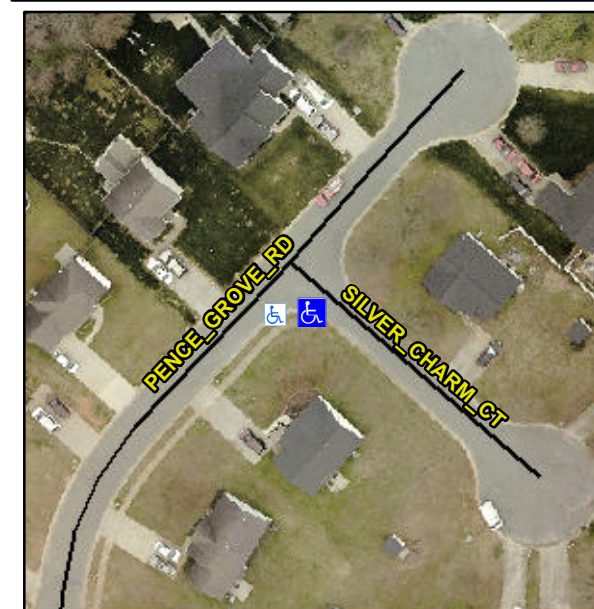
Not Found, R304.5.1

Compliance	Description	Data	Compliance	Description	Data
N/A	Ramp Length (in)	44.5	Yes	Ramp Slope (%)	6.8
No	Ramp Width (in)	42.0	Yes	Ramp XSlope (%)	1.2
N/A	Flare Type LT	N/A	N/A	Flare Type RT	N/A
N/A	Flare Slope LT (%)	N/A	N/A	Flare Slope RT (%)	N/A
N/A	Flare Traversable LT?	N/A	N/A	Flare Traversable RT?	N/A
N/A	Landing Length (in)	N/A	N/A	DWS Provided?	N/A
N/A	Landing Width (in)	N/A	N/A	DWS Contrast?	N/A
N/A	Landing Slope (%)	N/A	N/A	DWS Length (in)	N/A
N/A	Landing X Slope (%)	N/A	N/A	DWS Full Width?	N/A
N/A	Landing Curb? (Y/N)	N/A	N/A	DWS Offset (in)	N/A
N/A	Shared Landing?	N/A			
N/A	Gutter Ponding?	N/A	N/A	Gutter Slope (%)	N/A
N/A	Gutter Lip Ht (in)	N/A	N/A	Gutter X Slope (%)	N/A
N/A	Painted X Walk1?	No	N/A	Painted X Walk2?	N/A
	X Walk 1 Direction	To NE		X Walk 2 Direction	N/A
N/A	X Walk 1 Width (in)	N/A	N/A	X Walk 2 Width (in)	N/A
	X Walk 1 Slope (%)	0.7		X Walk 2 Slope (%)	N/A
	X Walk 1 X Slope (%)	1.1		X Walk 2 X Slope (%)	N/A

N/A	Ramp inside XWalk1?	N/A	N/A	Ramp inside XWalk2?	N/A
	Road Slope (%)	1.1	N/A	Clear Space?	N/A
	Road X Slope (%)	0.7	N/A	Clear Space to XWalk (in)	N/A
N/A	Any Obstructions?	N/A	N/A	Storm Grate/Utility Hazard?	N/A
	Obstruction Type			Storm Grate/Utility Type	
		N/A			N/A
			Yes	Surface Condition? (G/P)	Good

Remove & Replace Entire Ramp.
