Access Compliance Report Public Rights-of-Way (Curb Ramps)

Intersection ID: 10016063 Main Street: N_TRYON_ST Cross Street: N/A Location: NW Initial Pass/Fail: Fail **Overall Compliance: No** ADA ID: DED305CAF575 Ramp Type: Directional1 **Severity Score:** 1.25

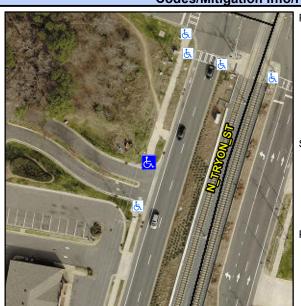
Compl	iance Description	Data	Compl	iance	Description	Data
N/A	Ramp Length (in)	91.0	N/A	Grade	e Break?	N/A
Yes	Ramp Width (in)	98.0	N/A	Grade	e Break Slope (%)	0.0
Yes	Ramp Slope (%)	3.9	N/A	Grade	e Break XSlope (%)	0.0
No	Ramp XSlope (%)	2.2				
N/A	Flare Type LT	N/A	N/A	Flare	Type RT	N/A
N/A	Flare Slope LT (%)	N/A	N/A	Flare	Slope RT (%)	0.0
N/A	Flare Traversable LT?	N/A	N/A	Flare	Traversable RT?	N/A
N/A	Landing Length (in)	0.0	N/A	DWS	Provided?	N/A
N/A	Landing Width (in)	0.0	N/A	DWS	Contrast?	N/A
N/A	Landing Slope (%)	0.0	N/A	DWS	Length (in)	N/A
N/A	Landing X Slope (%)	0.0	N/A	DWS	Full Width?	N/A
N/A	Landing Curb? (Y/N)	N/A	N/A	DWS	Offset LT (in)	N/A
N/A	Shared Landing?	N/A	N/A	DWS	Offset RT (in)	N/A
N/A	Gutter Ponding?	0.0	N/A	Gutte	r Slope (%)	N/A
N/A	Gutter Lip Ht (in)	0.0	N/A	Gutte	r X Slope (%)	N/A
N/A	Painted X Walk1?	No		Road	Slope (%)	1.8
	X Walk 1 Direction	To S		Road	X Slope (%)	0.4
	X Walk 1 Width (in)	N/A		Clear	Space?	N/A

X Walk 1 Slope (%)	1.8	N/A	Clear	Space to XWalk (in)	N/A
	X Walk 1 X Slope (%)	0.4	N/A	Storm	Grate/Utility Hazard?	N/A
N/A	Ramp inside XWalk1?	N/A		Storm	Grate/Utility Type	
N/A	Any Obstructions?	N/A				N/A
	Obstruction Type		Yes	Surfa	ce Condition? (G/P)	Good
		N/A	N/A	Curb	Slope (%)	6.1

OSSIDIC OCIULION	
Possible Solutions:	Comp
Remove & Replace Entire Ramp.	N/A
·	Yes
	Yes
	No
	N/A
	N/A
Surveyor Notes:	N/A
N/A	N/A
	N/A
	N/A
	N/A
PROW/ADA:	N/A
R304.5.3	N/A
	N/A
	N/A
	N/A

N/A
		N/A
		N/A
		N/A
\$	1600.00
