Intersection ID: 31212	Main Street: GRANTHAM_LN	Cross Street: WESTBURY_GLEN_CT	Location:	NE
ADA ID: DED3E6D80ED9	Ramp Type: PerpDiag	Initial Pass/Fail: Fail	Overall Compliance: No	Severity Score: 21.25

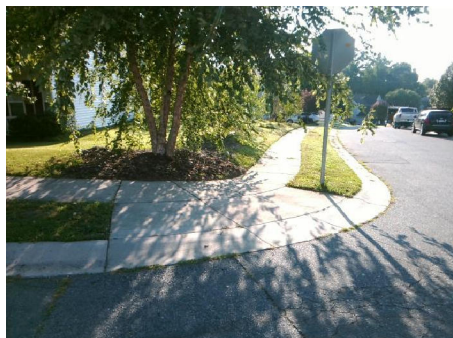
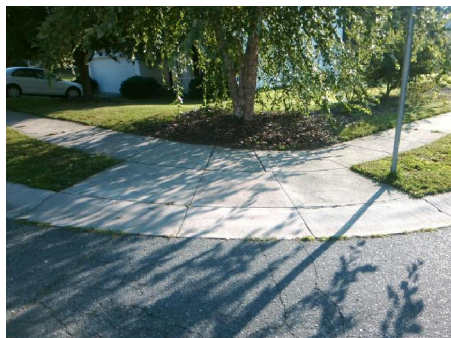
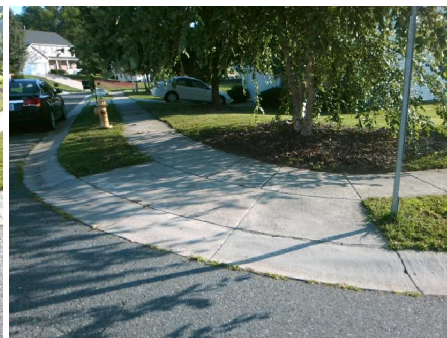
Codes/Mitigation Info/Possible Solution			Field Measurements/Component Compliance					
	Possible Solutions:		Compliance	Description	Data	Compliance	Description	Data
	Remove & Replace Curb Ramp With Two New Directional Ramps or Equivalent.		N/A	Ramp Length (in)	47.0	Yes	Ramp Slope (%)	5.0
			No	Ramp Width (in)	39.0	No	Ramp XSlope (%)	6.3
			N/A	Flare Type LT	N/A	N/A	Flare Type RT	N/A
			N/A	Flare Slope LT (%)	N/A	N/A	Flare Slope RT (%)	N/A
			N/A	Flare Traversable LT?	N/A	N/A	Flare Traversable RT?	N/A
			N/A	Landing Length (in)	N/A	N/A	DWS Provided?	N/A
			N/A	Landing Width (in)	N/A	N/A	DWS Contrast?	N/A
			N/A	Landing Slope (%)	N/A	N/A	DWS Length (in)	N/A
			N/A	Landing X Slope (%)	N/A	N/A	DWS Full Width?	N/A
Surveyor Notes:		N/A	N/A	Landing Curb? (Y/N)	N/A	N/A	DWS Offset (in)	N/A
PROW/ADA:		Not Found, R304.5.1, R304.5.3	N/A	Shared Landing?	N/A			
			N/A	Gutter Ponding?	N/A	N/A	Gutter Slope (%)	N/A
			N/A	Gutter Lip Ht (in)	N/A	N/A	Gutter X Slope (%)	N/A

N/A	Painted X Walk1?	No	N/A	Painted X Walk2?	No
				X Walk 1 Direction	To W		X Walk 2 Direction	To S
			N/A	X Walk 1 Width (in)	N/A	N/A	X Walk 2 Width (in)	N/A
				X Walk 1 Slope (%)	4.9		X Walk 2 Slope (%)	1.5
				X Walk 1 X Slope (%)	4.7		X Walk 2 X Slope (%)	4.7
			N/A	Ramp inside XWalk1?	N/A	N/A	Ramp inside XWalk2?	N/A
				Road Slope (%)	8.5	N/A	Clear Space?	N/A
				Road X Slope (%)	5.3	N/A	Clear Space to XWalk (in)	N/A
			N/A	Any Obstructions?	N/A	N/A	Storm Grate/Utility Hazard?	N/A
				Obstruction Type			Storm Grate/Utility Type	
					N/A			N/A
						Yes	Surface Condition? (G/P)	Good
Street 1 Name		WESTBURY GLEN CT						
Stop Condition-Street 2		None						
Street 2 Name		GRANTHAM LN						
Stop Condition-Street 1		StopSign						
Total Cost:		\$ 3200.00
