Access Compliance Report

Public Rights-of-Way

(Curb Ramps)

Intersection ID: 44304	Main Street: KIEV_DR	Cross Street: MALLORY_TAYLOR_LN	Location: NW
ADA ID: DED6893EC279	Ramp Type: PerpDiag	Initial Pass/Fail: Fail	Overall Compliance: No
Severity Score: 8.75			
Codes/Mitigation Info/Possible Solution		Field Measurements/Component Compliance

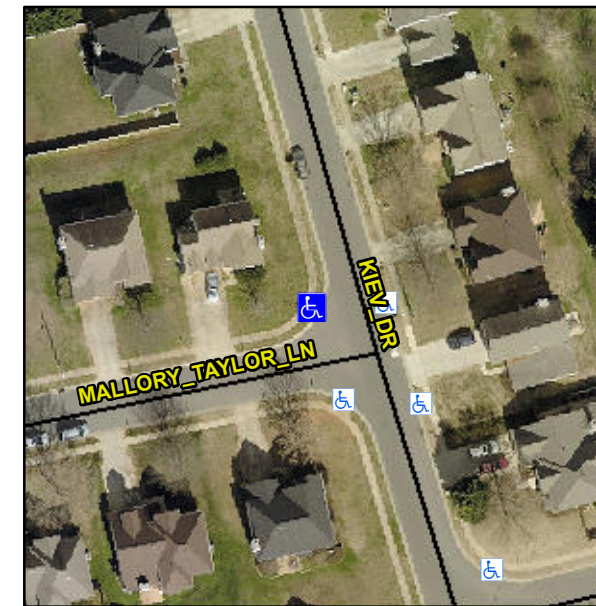
Not Found, R304.5.1

Compliance	Description	Data	Compliance	Description	Data
N/A	Ramp Length (in)	47.0	Yes	Ramp Slope (%)	5.4
No	Ramp Width (in)	46.0	Yes	Ramp XSlope (%)	0.3
N/A	Flare Type LT	N/A	N/A	Flare Type RT	N/A
N/A	Flare Slope LT (%)	N/A	N/A	Flare Slope RT (%)	N/A
N/A	Flare Traversable LT?	N/A	N/A	Flare Traversable RT?	N/A
N/A	Landing Length (in)	N/A	N/A	DWS Provided?	N/A
N/A	Landing Width (in)	N/A	N/A	DWS Contrast?	N/A
N/A	Landing Slope (%)	N/A	N/A	DWS Length (in)	N/A
N/A	Landing X Slope (%)	N/A	N/A	DWS Full Width?	N/A
N/A	Landing Curb? (Y/N)	N/A	N/A	DWS Offset (in)	N/A
N/A	Shared Landing?	N/A			
N/A	Gutter Ponding?	N/A	N/A	Gutter Slope (%)	N/A
N/A	Gutter Lip Ht (in)	N/A	N/A	Gutter X Slope (%)	N/A
N/A	Painted X Walk1?	No	N/A	Painted X Walk2?	No
	X Walk 1 Direction	To E		X Walk 2 Direction	To S
N/A	X Walk 1 Width (in)	N/A	N/A	X Walk 2 Width (in)	N/A
	X Walk 1 Slope (%)	1.2		X Walk 2 Slope (%)	2.3
	X Walk 1 X Slope (%)	2.1		X Walk 2 X Slope (%)	2.6

N/A	Ramp inside XWalk1?	N/A	N/A	Ramp inside XWalk2?	N/A
	Road Slope (%)	0.4	N/A	Clear Space?	N/A
	Road X Slope (%)	2.1	N/A	Clear Space to XWalk (in)	N/A
N/A	Any Obstructions?	N/A	N/A	Storm Grate/Utility Hazard?	N/A
	Obstruction Type			Storm Grate/Utility Type	
		N/A			N/A
			Yes	Surface Condition? (G/P)	Good

Remove & Replace Curb Ramp With Two New Directional Ramps or Equivalent.
