Access Compliance Report

Public Rights-of-Way

(Curb Ramps)

Intersection ID: 21898	Main Street: FOUNTAINHILL RIDGE RD	Cross Street: MILL POND RD	Location: W
ADA ID: DED995174D7C	Ramp Type: PerpDiag	Initial Pass/Fail: Fail	Overall Compliance: No
Severity Score: 33.75			
Codes/Mitigation Info/Possible Solution		Field Measurements/Component Compliance

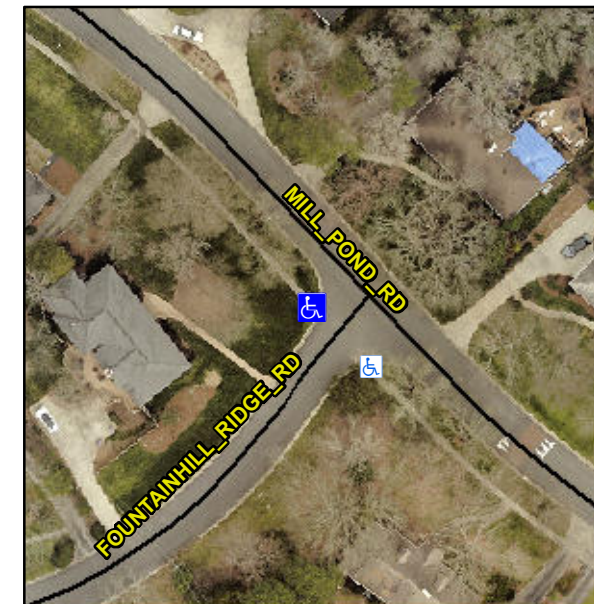
Not Found, R304.5.1, R304.5.3

Compliance	Description	Data	Compliance	Description	Data
N/A	Ramp Length (in)	38.0	Yes	Ramp Slope (%)	7.3
No	Ramp Width (in)	46.0	No	Ramp XSlope (%)	14.3
N/A	Flare Type LT	N/A	N/A	Flare Type RT	N/A
N/A	Flare Slope LT (%)	N/A	N/A	Flare Slope RT (%)	N/A
N/A	Flare Traversable LT?	N/A	N/A	Flare Traversable RT?	N/A
N/A	Landing Length (in)	N/A	N/A	DWS Provided?	N/A
N/A	Landing Width (in)	N/A	N/A	DWS Contrast?	N/A
N/A	Landing Slope (%)	N/A	N/A	DWS Length (in)	N/A
N/A	Landing X Slope (%)	N/A	N/A	DWS Full Width?	N/A
N/A	Landing Curb? (Y/N)	N/A	N/A	DWS Offset (in)	N/A
N/A	Shared Landing?	N/A			
N/A	Gutter Ponding?	N/A	N/A	Gutter Slope (%)	N/A
N/A	Gutter Lip Ht (in)	N/A	N/A	Gutter X Slope (%)	N/A
N/A	Painted X Walk1?	No	N/A	Painted X Walk2?	No
	X Walk 1 Direction	To SE		X Walk 2 Direction	To NE
N/A	X Walk 1 Width (in)	N/A	N/A	X Walk 2 Width (in)	N/A
	X Walk 1 Slope (%)	10.6		X Walk 2 Slope (%)	5.4
	X Walk 1 X Slope (%)	6.4		X Walk 2 X Slope (%)	15.7

N/A	Ramp inside XWalk1?	N/A	N/A	Ramp inside XWalk2?	N/A
	Road Slope (%)	12.9	N/A	Clear Space?	N/A
	Road X Slope (%)	11.3	N/A	Clear Space to XWalk (in)	N/A
N/A	Any Obstructions?	N/A	N/A	Storm Grate/Utility Hazard?	N/A
	Obstruction Type			Storm Grate/Utility Type	
		N/A			N/A
			Yes	Surface Condition? (G/P)	Good

Remove & Replace Curb Ramp With Two New Directional Ramps or Equivalent.
