Access Compliance Report Public Rights-of-Way (Curb Ramps)

Intersection ID: 10032788 Main Street: N_WENDOVER_RD Cross Street: N/A Location: NE **Overall Compliance: No Severity Score: ADA ID: DEE2399FA078** Ramp Type: Directional1 Initial Pass/Fail: Fail 50

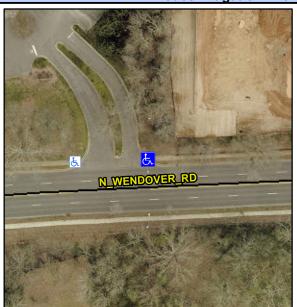
Possible Solution			Field Measurements/Component Compliance					
Possible Solutions:			Compliance Description		Data	Compliance Description		
Remove & Replace Entir	e Ran	np.	N/A	Ramp Length (in)	29.0	N/A	Grade Break?

•		•	Yes	Ramp Width (in)	57.0	N/A	Grade Break Slope (%)	
			No	Ramp Slope (%)	12.1	N/A	Grade Break XSlope (%)	
			No	Ramp XSlope (%)	9.4			
			N/A	Flare Type LT	N/A	N/A	Flare Type RT	
			N/A	Flare Slope LT (%)	N/A	N/A	Flare Slope RT (%)	
Surveyor Notes:			N/A	Flare Traversable LT?	N/A	N/A	Flare Traversable RT?	
N/A			N/A	Landing Length (in)	0.0	N/A	DWS Provided?	
			N/A	Landing Width (in)	0.0	N/A	DWS Contrast?	
			N/A	Landing Slope (%)	0.0	N/A	DWS Length (in)	
			N/A	Landing X Slope (%)	0.0	N/A	DWS Full Width?	
PROW/ADA:			N/A	Landing Curb? (Y/N)	N/A	N/A	DWS Offset LT (in)	
R304.2.2, R304.5.3			N/A	Shared Landing?	N/A	N/A	DWS Offset RT (in)	
			N/A	Gutter Ponding?	0.0	N/A	Gutter Slope (%)	
			N/A	Gutter Lip Ht (in)	0.0	N/A	Gutter X Slope (%)	
			N/A	Painted X Walk1?	No		Road Slope (%)	
				X Walk 1 Direction	To W		Road X Slope (%)	
				X Walk 1 Width (in)	N/A		Clear Space?	
				X Walk 1 Slope (%)	4.6	N/A	Clear Space to XWalk (in)

X Walk 1 X Slope (%)	2.4	N/A	Storm Grate/Utility Hazard?	
			N/A	Ramp inside XWalk1?	N/A		Storm Grate/Utility Type	
			N/A	Any Obstructions?	N/A			
Total Cost:	\$	1600.00		Obstruction Type		Yes	Surface Condition? (G/P)	
					N/A	N/A	Curb Slope (%)
