# Access Compliance Report

## Public Rights-of-Way

### (Curb Ramps)

Intersection ID: 32276	Main Street: SULLIVAN_RIDGE_DR	Cross Street: WILLOUGHBY_RUN_DR	Location: NE
ADA ID: DEEC862BE08A	Ramp Type: PerpDiag	Initial Pass/Fail: Fail	Overall Compliance: No
Severity Score: 46.25			
Codes/Mitigation Info/Possible Solution		Field Measurements/Component Compliance

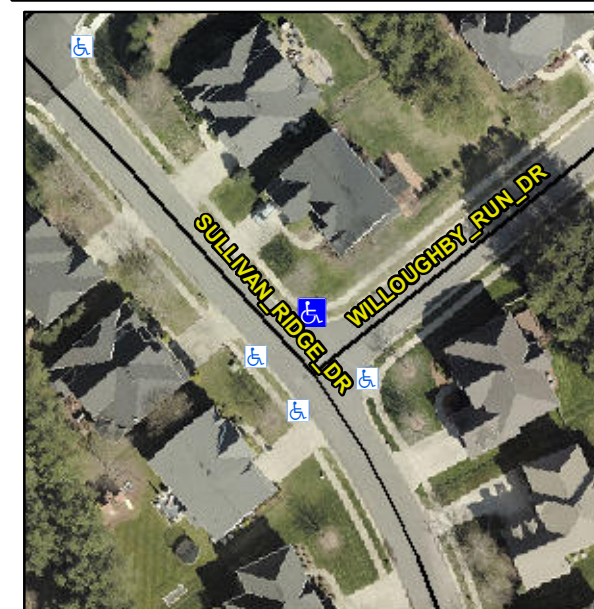
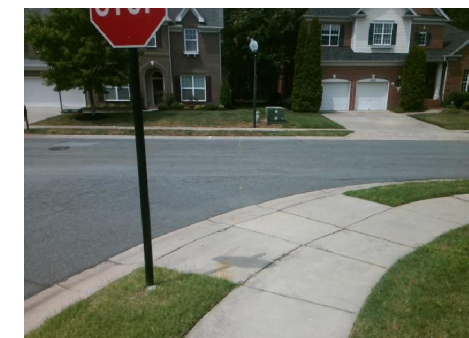
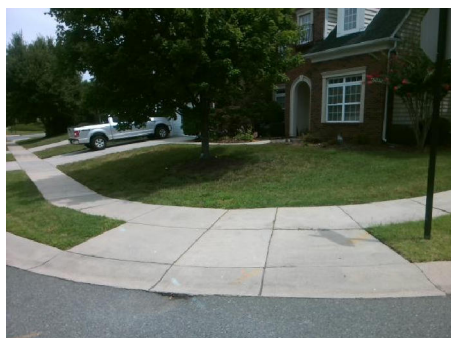
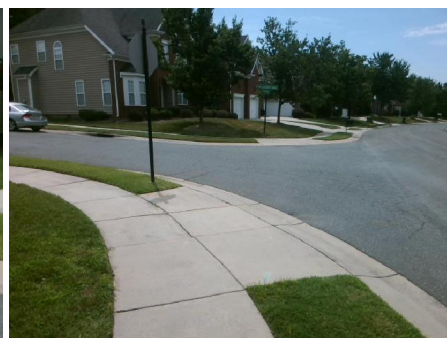
Compliance	Description	Data	Compliance	Description	Data
N/A	Ramp Length (in)	96.0	No	Ramp Slope (%)	9.9
No	Ramp Width (in)	37.5	No	Ramp XSlope (%)	7.7
N/A	Flare Type LT	N/A	N/A	Flare Type RT	N/A
N/A	Flare Slope LT (%)	N/A	N/A	Flare Slope RT (%)	N/A
N/A	Flare Traversable LT?	N/A	N/A	Flare Traversable RT?	N/A
N/A	Landing Length (in)	N/A	N/A	DWS Provided?	N/A
N/A	Landing Width (in)	N/A	N/A	DWS Contrast?	N/A
N/A	Landing Slope (%)	N/A	N/A	DWS Length (in)	N/A
N/A	Landing X Slope (%)	N/A	N/A	DWS Full Width?	N/A
N/A	Landing Curb? (Y/N)	N/A	N/A	DWS Offset (in)	N/A
N/A	Shared Landing?	N/A			
N/A	Gutter Ponding?	N/A	N/A	Gutter Slope (%)	N/A
N/A	Gutter Lip Ht (in)	2.0	N/A	Gutter X Slope (%)	N/A
N/A	Painted X Walk1?	No	N/A	Painted X Walk2?	No
	X Walk 1 Direction	To SW		X Walk 2 Direction	To SE
N/A	X Walk 1 Width (in)	N/A	N/A	X Walk 2 Width (in)	N/A
	X Walk 1 Slope (%)	0.9		X Walk 2 Slope (%)	2.0
	X Walk 1 X Slope (%)	4.0		X Walk 2 X Slope (%)	2.8

N/A	Ramp inside XWalk1?	N/A	N/A	Ramp inside XWalk2?	N/A
	Road Slope (%)	4.0	N/A	Clear Space?	N/A
	Road X Slope (%)	4.5	N/A	Clear Space to XWalk (in)	N/A
N/A	Any Obstructions?	N/A	N/A	Storm Grate/Utility Hazard?	N/A
	Obstruction Type			Storm Grate/Utility Type	
		N/A			N/A
			Yes	Surface Condition? (G/P)	Good

**Remove & Replace Curb Ramp With Two New Directional Ramps or Equivalent.**

**Not Found, R304.5.1, R304.2.2, R304.5.3**
