Access Compliance Report

Public Rights-of-Way

(Curb Ramps)

Intersection ID: 10020180	Main Street: AUBURN_AV	Cross Street: N/A	Location: S
ADA ID: DEECB3138D8C	Ramp Type: PerpDiag	Initial Pass/Fail: Fail	Overall Compliance: No
Severity Score: 22.5			
Codes/Mitigation Info/Possible Solution		Field Measurements/Component Compliance

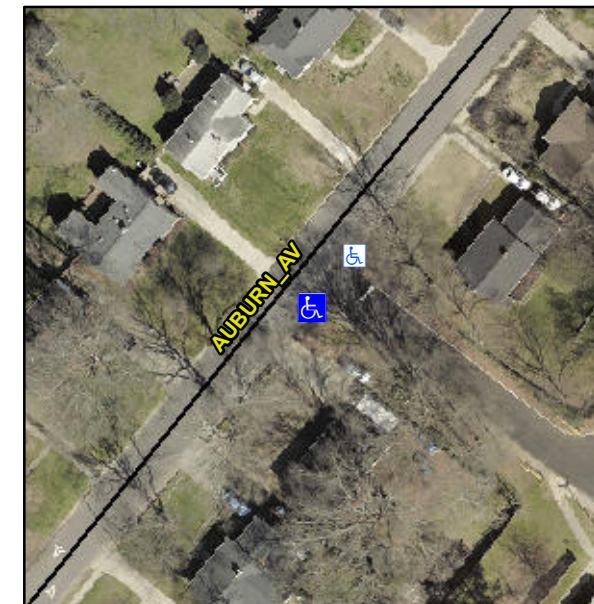
Not Found, R304.5.1, R304.2.2

Compliance	Description	Data	Compliance	Description	Data
N/A	Ramp Length (in)	34.0	No	Ramp Slope (%)	11.4
No	Ramp Width (in)	36.0	Yes	Ramp XSlope (%)	4.7
N/A	Flare Type LT	N/A	N/A	Flare Type RT	N/A
N/A	Flare Slope LT (%)	N/A	N/A	Flare Slope RT (%)	N/A
N/A	Flare Traversable LT?	N/A	N/A	Flare Traversable RT?	N/A
N/A	Landing Length (in)	N/A	N/A	DWS Provided?	N/A
N/A	Landing Width (in)	N/A	N/A	DWS Contrast?	N/A
N/A	Landing Slope (%)	N/A	N/A	DWS Length (in)	N/A
N/A	Landing X Slope (%)	N/A	N/A	DWS Full Width?	N/A
N/A	Landing Curb? (Y/N)	N/A	N/A	DWS Offset (in)	N/A
N/A	Shared Landing?	N/A			
N/A	Gutter Ponding?	N/A	N/A	Gutter Slope (%)	N/A
N/A	Gutter Lip Ht (in)	N/A	N/A	Gutter X Slope (%)	N/A
N/A	Painted X Walk1?	No	N/A	Painted X Walk2?	No
	X Walk 1 Direction	To NE		X Walk 2 Direction	To NW
N/A	X Walk 1 Width (in)	N/A	N/A	X Walk 2 Width (in)	N/A
	X Walk 1 Slope (%)	4.2		X Walk 2 Slope (%)	1.5
	X Walk 1 X Slope (%)	4.7		X Walk 2 X Slope (%)	2.2

N/A	Ramp inside XWalk1?	N/A	N/A	Ramp inside XWalk2?	N/A
	Road Slope (%)	5.3	N/A	Clear Space?	N/A
	Road X Slope (%)	1.1	N/A	Clear Space to XWalk (in)	N/A
N/A	Any Obstructions?	N/A	N/A	Storm Grate/Utility Hazard?	N/A
	Obstruction Type			Storm Grate/Utility Type	
		N/A			N/A
			Yes	Surface Condition? (G/P)	Good

Possible Solutions:

Remove & Replace Curb Ramp With Two New Directional Ramps or Equivalent.
