Access Compliance Report

Public Rights-of-Way

(Curb Ramps)

Intersection ID: 14762	Main Street: E_TREMONT_AV	Cross Street: SPRINGDALE_AV	Location:	E
ADA ID: DEF1C86D118C	Ramp Type: Directional1	Initial Pass/Fail: Fail	Overall Compliance: No	Severity Score: 10

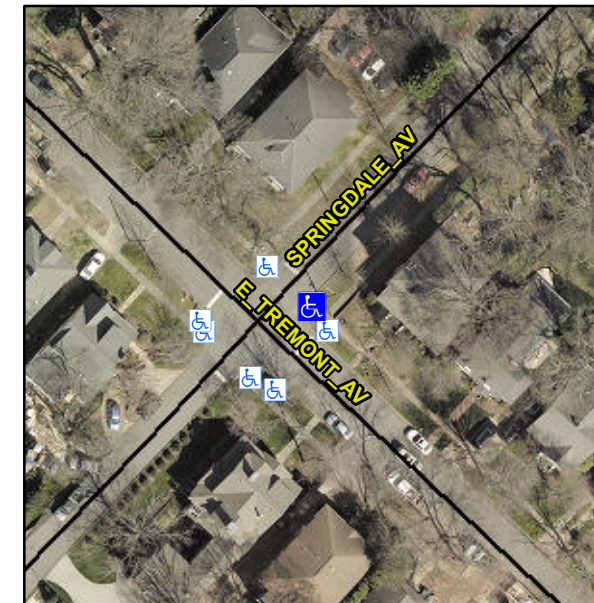
Compliance	Description	Data	Compliance	Description	Data
N/A	Ramp Length (in)	28.0	N/A	Grade Break?	N/A
No	Ramp Width (in)	47.0	N/A	Grade Break Slope (%)	0.0
Yes	Ramp Slope (%)	2.1	N/A	Grade Break XSlope (%)	0.0
No	Ramp XSlope (%)	2.7			
N/A	Flare Type LT	N/A	N/A	Flare Type RT	N/A
N/A	Flare Slope LT (%)	N/A	N/A	Flare Slope RT (%)	0.0
N/A	Flare Traversable LT?	N/A	N/A	Flare Traversable RT?	N/A
N/A	Landing Length (in)	0.0	N/A	DWS Provided?	N/A
N/A	Landing Width (in)	0.0	N/A	DWS Contrast?	N/A
N/A	Landing Slope (%)	0.0	N/A	DWS Length (in)	N/A
N/A	Landing X Slope (%)	0.0	N/A	DWS Full Width?	N/A
N/A	Landing Curb? (Y/N)	N/A	N/A	DWS Offset LT (in)	N/A
N/A	Shared Landing?	N/A	N/A	DWS Offset RT (in)	N/A
N/A	Gutter Ponding?	0.0	N/A	Gutter Slope (%)	N/A
N/A	Gutter Lip Ht (in)	0.0	N/A	Gutter X Slope (%)	N/A
N/A	Painted X Walk1?	No		Road Slope (%)	3.1
	X Walk 1 Direction	To NW		Road X Slope (%)	4.1
	X Walk 1 Width (in)	N/A		Clear Space?	N/A

X Walk 1 Slope (%)	3.1	N/A	Clear Space to XWalk (in)	N/A
	X Walk 1 X Slope (%)	4.1	N/A	Storm Grate/Utility Hazard?	N/A
N/A	Ramp inside XWalk1?	N/A		Storm Grate/Utility Type	
N/A	Any Obstructions?	N/A			N/A
	Obstruction Type		Yes	Surface Condition? (G/P)	Good
			N/A	Curb Slope (%)	17.8

Remove & Replace Entire Ramp.
