Access Compliance Report

Public Rights-of-Way

(Curb Ramps)

Intersection ID: 19122	Main Street: AMRITA_CT	Cross Street: RANDOLPH_RD	Location: NE
ADA ID: DEF1D27C98B4	Ramp Type: Directional1	Initial Pass/Fail: Fail	Overall Compliance: No
Severity Score: 13.75			
Codes/Mitigation Info/Possible Solution		Field Measurements/Component Compliance

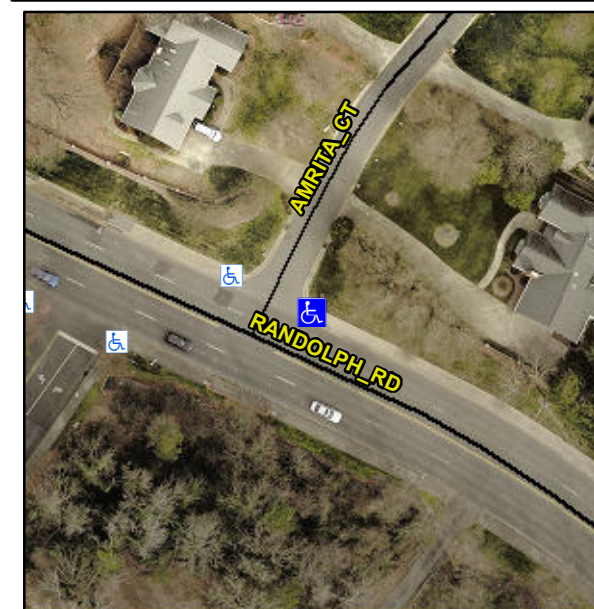
Compliance	Description	Data	Compliance	Description	Data
N/A	Ramp Length (in)	40.0	N/A	Grade Break?	N/A
Yes	Ramp Width (in)	51.0	N/A	Grade Break Slope (%)	0.0
No	Ramp Slope (%)	10.5	N/A	Grade Break XSlope (%)	0.0
No	Ramp XSlope (%)	2.9			
N/A	Flare Type LT	N/A	N/A	Flare Type RT	N/A
N/A	Flare Slope LT (%)	N/A	N/A	Flare Slope RT (%)	0.0
N/A	Flare Traversable LT?	N/A	N/A	Flare Traversable RT?	N/A
N/A	Landing Length (in)	0.0	N/A	DWS Provided?	N/A
N/A	Landing Width (in)	0.0	N/A	DWS Contrast?	N/A
N/A	Landing Slope (%)	0.0	N/A	DWS Length (in)	N/A
N/A	Landing X Slope (%)	0.0	N/A	DWS Full Width?	N/A
N/A	Landing Curb? (Y/N)	N/A	N/A	DWS Offset LT (in)	N/A
N/A	Shared Landing?	N/A	N/A	DWS Offset RT (in)	N/A
N/A	Gutter Ponding?	0.0	N/A	Gutter Slope (%)	N/A
N/A	Gutter Lip Ht (in)	0.0	N/A	Gutter X Slope (%)	N/A
N/A	Painted X Walk1?	No		Road Slope (%)	1.1
	X Walk 1 Direction	To W		Road X Slope (%)	6.1
	X Walk 1 Width (in)	N/A		Clear Space?	N/A

X Walk 1 Slope (%)	1.1	N/A	Clear Space to XWalk (in)	N/A
	X Walk 1 X Slope (%)	6.1	N/A	Storm Grate/Utility Hazard?	N/A
N/A	Ramp inside XWalk1?	N/A		Storm Grate/Utility Type	
N/A	Any Obstructions?	N/A			N/A
	Obstruction Type		Yes	Surface Condition? (G/P)	Good
			N/A	Curb Slope (%)	8.0

Possible Solutions:

Remove & Replace Entire Ramp.
