Access Compliance Report Public Rights-of-Way (Curb Ramps)

Intersection ID: 3373 Main Street: KATELYN_DR Cross Street: PROSPERITY_CHURCH_RD Location: S

ADA ID: DF19901235F0 Ramp Type: Perp Initial Pass/Fail: Fail Overall Compliance: No Severity Score: 8.75

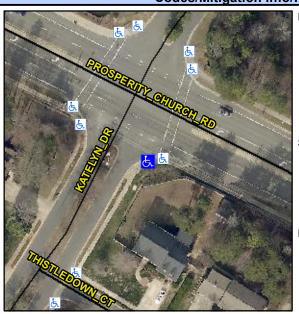
Not Found, R304.5.1

Pried Measurements/Component Compliance					
	liance Description	Data		liance Description	Data
N/A	Ramp Length (in)	71.5	Yes	Ramp Slope (%)	7.3
No	Ramp Width (in)	40.0	Yes	Ramp XSlope (%)	1.4
N/A	Flare Type LT	N/A	N/A	Flare Type RT	N/A
N/A	Flare Slope LT (%)	N/A	N/A	Flare Slope RT (%)	N/A
N/A	Flare Traversable LT?	N/A	N/A	Flare Traversable RT?	N/A
N/A	Landing Length (in)	N/A	N/A	DWS Provided?	N/A
N/A	Landing Width (in)	N/A	N/A	DWS Contrast?	N/A
N/A	Landing Slope (%)	N/A	N/A	DWS Length (in)	N/A
N/A	Landing X Slope (%)	N/A	N/A	DWS Full Width?	N/A
N/A	Landing Curb? (Y/N)	N/A	N/A	DWS Offset (in)	N/A
N/A	Shared Landing?	N/A			
N/A	Gutter Ponding?	N/A	N/A	Gutter Slope (%)	N/A
N/A	Gutter Lip Ht (in)	N/A	N/A	Gutter X Slope (%)	N/A
N/A	Painted X Walk1?	No	N/A	Painted X Walk2?	N/A
	X Walk 1 Direction	To NW		X Walk 2 Direction	N/A
N/A	X Walk 1 Width (in)	N/A	N/A	X Walk 2 Width (in)	N/A
	X Walk 1 Slope (%)	0.7		X Walk 2 Slope (%)	N/A

X Walk 1 X Slope (%)	3.3		X Walk 2 X Slope (%)	N/A
N/A	Ramp inside XWalk1?	N/A	N/A	Ramp inside XWalk2?	N/A
	Road Slope (%)	N/A	N/A	Clear Space?	N/A
	Road X Slope (%)	N/A	N/A	Clear Space to XWalk (in)	N/A
N/A	Any Obstructions?	N/A	N/A	Storm Grate/Utility Hazard?	N/A
	Obstruction Type			Storm Grate/Utility Type	
		N/A			N/A
			Yes	Surface Condition? (G/P)	Good
	iiiiiiiiiiiiiiiiiiiiiiiiiiiiiiiiiiiiii

Remove & Replace Entire Ramp.
