Access Compliance Report Public Rights-of-Way (Curb Ramps)

Intersection ID: 27020 Main Street: LINKS DR **Cross Street: SETON HOUSE LN** Location: ADA ID: DF1D900B1303 Ramp Type: PerpDiag Initial Pass/Fail: Fail **Overall Compliance: No** Severity Score: 21.25

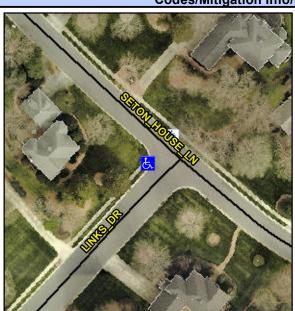
Comp	liance Description	Data	Comp	liance Description	Data
N/A	Ramp Length (in)	57.5	No	Ramp Slope (%)	9.2
No	Ramp Width (in)	42.5	Yes	Ramp XSlope (%)	0.2
N/A	Flare Type LT	N/A	N/A	Flare Type RT	N/A
N/A	Flare Slope LT (%)	N/A	N/A	Flare Slope RT (%)	N/A
N/A	Flare Traversable LT?	N/A	N/A	Flare Traversable RT?	N/A
N/A	Landing Length (in)	N/A	N/A	DWS Provided?	N/A
N/A	Landing Width (in)	N/A	N/A	DWS Contrast?	N/A
N/A	Landing Slope (%)	N/A	N/A	DWS Length (in)	N/A
N/A	Landing X Slope (%)	N/A	N/A	DWS Full Width?	N/A
N/A	Landing Curb? (Y/N)	N/A	N/A	DWS Offset (in)	N/A
N/A	Shared Landing?	N/A			
N/A	Gutter Ponding?	N/A	N/A	Gutter Slope (%)	N/A
N/A	Gutter Lip Ht (in)	N/A	N/A	Gutter X Slope (%)	N/A
N/A	Painted X Walk1?	No	N/A	Painted X Walk2?	No
	X Walk 1 Direction	To SE		X Walk 2 Direction	To NE
N/A	X Walk 1 Width (in)	N/A	N/A	X Walk 2 Width (in)	N/A
	X Walk 1 Slope (%)	4.1		X Walk 2 Slope (%)	2.2
	X Walk 1 X Slope (%)	0.2		X Walk 2 X Slope (%)	3.4

N/A	Ramp inside XWalk1?	N/A	N/A	Ramp inside XWalk2?	N/A
	Road Slope (%)	2.4	N/A	Clear Space?	N/A
	Road X Slope (%)	2.4	N/A	Clear Space to XWalk (in)	N/A
N/A	Any Obstructions?	N/A	N/A	Storm Grate/Utility Hazard?	N/A
	Obstruction Type		l	Storm Grate/Utility Type	
		N/A			N/A
			Yes	Surface Condition? (G/P)	Good

Possible Solutions: Remove & Replace Curb Ramp With **Two New Directional Ramps or** Equivalent.

W/ADA: t Found,	R304.5.1	, R304	.2.2		
Cost:			\$	3200.00
