## Access Compliance Report Public Rights-of-Way (Curb Ramps)

ntersection ID: 10018021 Main Street: EARGLE_RD			Cross Street: N/A					Location:	SE		
ADA ID: DF2F680F3058 Ramp Type: Perp			Initial Pass/Fail: Fail Overall Compliance: No					o Severity Score:	37.5		
Codes/Mitigation Info/Possible Solution					Field Measurements/Component Compliance						
the law of the	131 13	Possible Solutions:		Compliance Description Da			Data	ata Compliance Description		Data	
	A BOAR	Remove & Replace Enti	re Ramp	-	N/A	Ramp Length (in)	52.0	No	Ramp Slope (%)	10.0	
	1 A. C	· · · · · · · · · · · · · · · · · · ·	· · · · · · · · · · · · · · · · · · ·		No	Ramp Width (in)	45.0	Yes	Ramp XSlope (%)	2.5	
the second second	1 6. A				N/A	Flare Type LT	N/A	N/A	Flare Type RT	N/A	
PRESIMANIN_OT	1	4 *			N/A	Flare Slope LT (%)	N/A	N/A	Flare Slope RT (%)	N/A	
ь 🛃	the second se				N/A	Flare Traversable LT?	N/A	N/A	Flare Traversable RT?	N/A	
	h and	5			N/A	Landing Length (in)	N/A	N/A	DWS Provided?	N/A

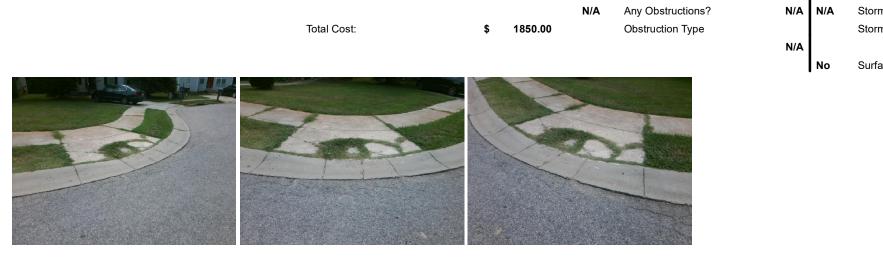
- Carlos				N/A	Landing Curb? (Y/N)	N/A	N/A	DWS Offset (in)	N/A	
1-	and the second				N/A	Shared Landing?	N/A				
	and the second	PROW/ADA:			N/A	Gutter Ponding?	N/A	N/A	Gutter Slope (%)	N/A	
	· 10 . 4. 30	Not Found, R304.5.1, R	304.2.2.		N/A	Gutter Lip Ht (in)	0.75	N/A	Gutter X Slope (%)	N/A	
the second to	· The	R302.7	•••·· <u></u> ,		N/A	Painted X Walk1?	No	N/A	Painted X Walk2?	N/A	
					X Walk 1 Direction	To W		X Walk 2 Direction	N/A		
					N/A	X Walk 1 Width (in)	N/A	N/A	X Walk 2 Width (in)	N/A	
Street 1 Name	EARGLE RD	_				X Walk 1 Slope (%)	3.8		X Walk 2 Slope (%)	N/A	
Stop Condition-Street 2	None					X Walk 1 X Slope (%)	4.1		X Walk 2 X Slope (%)	N/A	
Street 2 Name	N/A				N/A	Ramp inside XWalk1?	N/A	N/A	Ramp inside XWalk2?	N/A	
Stop Condition-Street 1	N/A					Road Slope (%)	N/A	N/A	Clear Space?	N/A	
						Road X Slope (%)	N/A	N/A	Clear Space to XWalk (in)	N/A	
					N/A	Any Obstructions?	N/A	N/A	Storm Grate/Utility Hazard?	N/A

• Surface Condition? (G/P)

Poor

Total Cost:	\$	1850.00		Obstruction Type			Storm Grate/Utility Type		
							N/A			N/A
