Access Compliance Report Public Rights-of-Way (Curb Ramps)

Intersection ID: 32275 Main Street: PRESCOTT HILL AV **Cross Street: SPRINGWELL ST** Location: SE **ADA ID: DF36EF62596B** Ramp Type: BlendTrans1 Initial Pass/Fail: Fail **Overall Compliance: No Severity Score:** 8.75

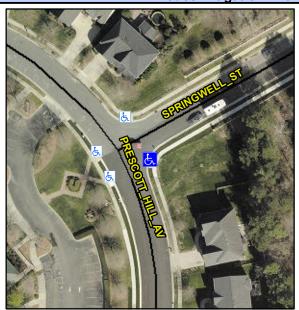
Compl	iance Description	Data	Comp	liance	Description	Data
N/A	Ramp Length (in)	49.0	Yes	Blend	Trans Slope (%)	4.7
No	Ramp Width (in)	45.0	Yes	Blend	Trans XSlope (%)	0.7
N/A	Flare Type LT	N/A	N/A	Flare	Type RT	N/A
N/A	Flare Slope LT (%)	N/A	N/A	Flare	Slope RT (%)	N/A
N/A	Flare Traversable LT?	N/A	N/A	Flare	Traversable RT?	N/A
N/A	Landing Length (in)	N/A	N/A	DWS	Provided?	N/A
N/A	Landing Width (in)	N/A	N/A	DWS	Contrast?	N/A
N/A	Landing Slope (%)	N/A	N/A	DWS	Length (in)	N/A
N/A	Landing X Slope (%)	N/A	N/A	DWS	Full Width?	N/A
N/A	Landing Curb? (Y/N)	N/A	N/A	DWS	Offset (in)	N/A
N/A	Shared Landing?	N/A				
N/A	Gutter Ponding?	N/A	N/A	Gutte	er Slope (%)	N/A
N/A	Gutter Lip Ht (in)	N/A	N/A	Gutte	er X Slope (%)	N/A
N/A	Painted X Walk1?	No	N/A	Paint	ed X Walk2?	No
	X Walk 1 Direction	To NW		X Wa	lk 2 Direction	To SW
	X Walk 1 Width (in)	N/A		X Wa	lk 2 Width (in)	N/A
	X Walk 1 Slope (%)	2.1		X Wa	lk 2 Slope (%)	3.1
	X Walk 1 X Slope (%)	3.0		X Wa	lk 2 X Slope (%)	0.5

N/A	Ramp inside XWalk1?	N/A	N/A	Ram	inside XWalk2?	N/A
	Road Slope (%)	1.4		Clear	Space?	N/A
	Road X Slope (%)	3.0	N/A	Clear	Space to XWalk (in)	N/A
N/A	Any Obstructions?	N/A	N/A	Storn	n Grate/Utility Hazard?	N/A
	Obstruction Type			Storn	n Grate/Utility Type	
		N/A				N/A
			Yes	Surfa	ce Condition? (G/P)	Good
AL	**		No	Curb	Slope (%)	6.5

Possible Solutions: **Remove & Replace Curb Ramp With** Two New Directional Ramps or Equivalent. Surveyor Notes: N/A PROW/ADA: Not Found, R304.5.1
