Access Compliance Report

Public Rights-of-Way

(Curb Ramps)

Intersection ID: 17009	Main Street: N_WENDOVER_RD	Cross Street: RANDOLPH_RD	Location:	E
ADA ID: DF3C64BD5986	Ramp Type: Perp	Initial Pass/Fail: Fail	Overall Compliance: No	Severity Score: 10

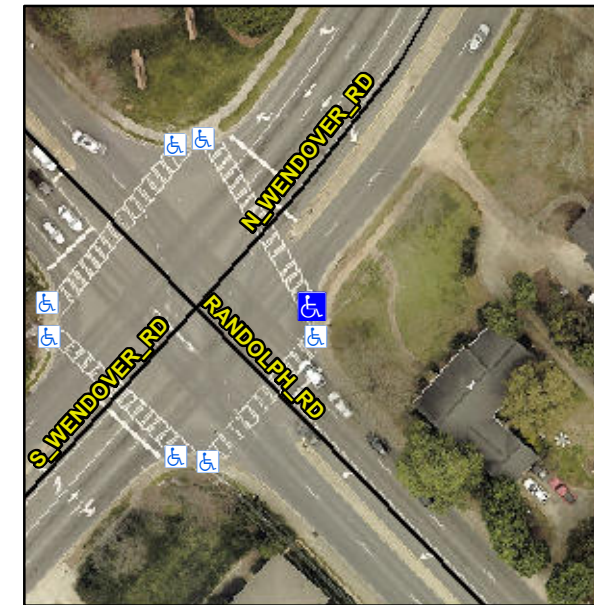
Not Found, R304.5.1, R304.5.3

Compliance	Description	Data	Compliance	Description	Data
N/A	Ramp Length (in)	89.0	Yes	Ramp Slope (%)	8.3
No	Ramp Width (in)	37.5	No	Ramp XSlope (%)	2.7
N/A	Flare Type LT	N/A	N/A	Flare Type RT	N/A
N/A	Flare Slope LT (%)	N/A	N/A	Flare Slope RT (%)	N/A
N/A	Flare Traversable LT?	N/A	N/A	Flare Traversable RT?	N/A
N/A	Landing Length (in)	N/A	N/A	DWS Provided?	N/A
N/A	Landing Width (in)	N/A	N/A	DWS Contrast?	N/A
N/A	Landing Slope (%)	N/A	N/A	DWS Length (in)	N/A
N/A	Landing X Slope (%)	N/A	N/A	DWS Full Width?	N/A
N/A	Landing Curb? (Y/N)	N/A	N/A	DWS Offset (in)	N/A
N/A	Shared Landing?	N/A			
N/A	Gutter Ponding?	N/A	N/A	Gutter Slope (%)	N/A
N/A	Gutter Lip Ht (in)	N/A	N/A	Gutter X Slope (%)	N/A
N/A	Painted X Walk1?	Yes	N/A	Painted X Walk2?	N/A
	X Walk 1 Direction	To NW		X Walk 2 Direction	N/A
N/A	X Walk 1 Width (in)	109.0	N/A	X Walk 2 Width (in)	N/A
	X Walk 1 Slope (%)	1.4		X Walk 2 Slope (%)	N/A
	X Walk 1 X Slope (%)	0.9		X Walk 2 X Slope (%)	N/A

N/A	Ramp inside XWalk1?	Yes	N/A	Ramp inside XWalk2?	N/A
	Road Slope (%)	N/A	N/A	Clear Space?	N/A
	Road X Slope (%)	N/A	N/A	Clear Space to XWalk (in)	N/A
N/A	Any Obstructions?	N/A	N/A	Storm Grate/Utility Hazard?	N/A
	Obstruction Type			Storm Grate/Utility Type	
		N/A			N/A
			Yes	Surface Condition? (G/P)	Good

Remove & Replace Entire Ramp.
