Access Compliance Report Public Rights-of-Way (Curb Ramps)

Intersection ID: 19012 Main Street: DEVERON DR Cross Street: RAMA RD Location: Ε Initial Pass/Fail: Fail **Overall Compliance: No** 30 **ADA ID: DF3E7F670D82** Ramp Type: PerpDiag **Severity Score:**

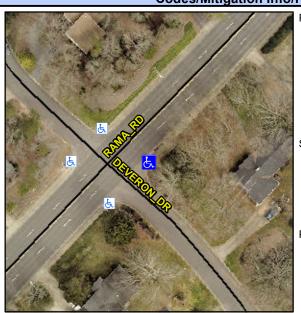
RAMA RD None **DEVERON DR** StopSign Possible Solutions: Remove & Replace Curb Ramp With Two New Directional Ramps or Equivalent. Surveyor Notes: N/A PROW/ADA: Not Found, R304.5.1, R304.2.2
