## **Access Compliance Report Public Rights-of-Way** (Curb Ramps)

Main Street: N GRAHAM ST Location: Intersection ID: 9129 **Cross Street: NORRIS AV** SW Initial Pass/Fail: Fail **Overall Compliance: No** 35 **ADA ID: DF489FE82E61** Ramp Type: Combination1 **Severity Score:**

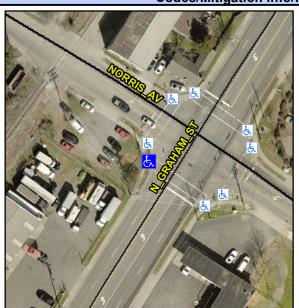
Street 1 Name Signal Stop Condition-Street 1 **N GRAHAM ST** N/A Street 2 Name Stop Condition-Street 2 N/A Possible Solutions: Compliance Description N/A Remove & Replace Entire Ramp. Yes Yes Yes N/A No Surveyor Notes: N/A LT RP < 5% N/A N/A N/A N/A PROW/ADA: N/A Not Found, R304.5.1, R304.5.3, N/A R304.3.2 N/A N/A N/A
