# Access Compliance Report

## Public Rights-of-Way

### (Curb Ramps)

Intersection ID: 13540	Main Street: LEXINGTON_AV	Cross Street: S_CALDWELL_ST	Location: S
ADA ID: DF4ADCC0888A	Ramp Type: BlendTrans1	Initial Pass/Fail: Fail	Overall Compliance: No
		Severity Score: 10

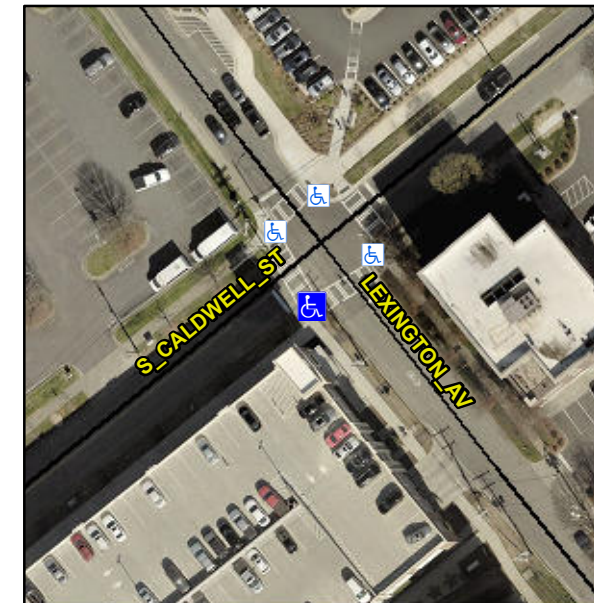
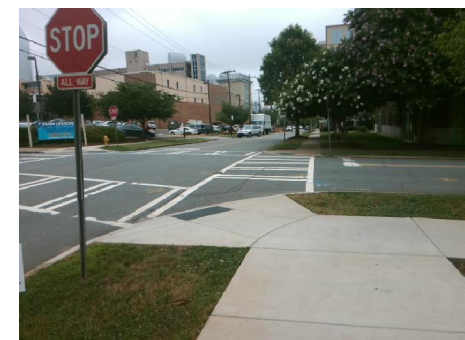
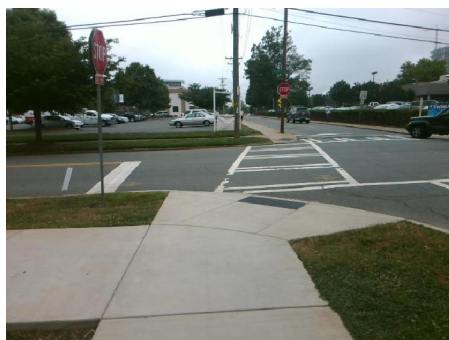
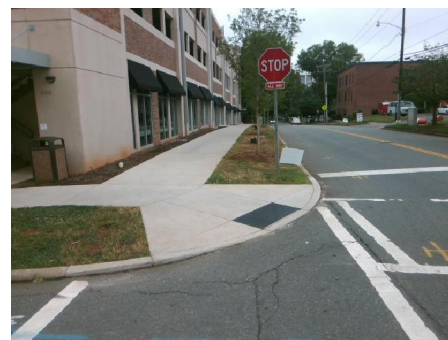
**Not Found, R304.5.1, R304.5.3**

Compliance	Description	Data	Compliance	Description	Data
N/A	Ramp Length (in)	91.0	Yes	BlendTrans Slope (%)	3.2
No	Ramp Width (in)	47.0	No	BlendTrans XSlope (%)	2.3
N/A	Flare Type LT	N/A	N/A	Flare Type RT	N/A
N/A	Flare Slope LT (%)	N/A	N/A	Flare Slope RT (%)	N/A
N/A	Flare Traversable LT?	N/A	N/A	Flare Traversable RT?	N/A
N/A	Landing Length (in)	N/A	N/A	DWS Provided?	N/A
N/A	Landing Width (in)	N/A	N/A	DWS Contrast?	N/A
N/A	Landing Slope (%)	N/A	N/A	DWS Length (in)	N/A
N/A	Landing X Slope (%)	N/A	N/A	DWS Full Width?	N/A
N/A	Landing Curb? (Y/N)	N/A	N/A	DWS Offset (in)	N/A
N/A	Shared Landing?	N/A			
N/A	Gutter Ponding?	N/A	N/A	Gutter Slope (%)	N/A
N/A	Gutter Lip Ht (in)	N/A	N/A	Gutter X Slope (%)	N/A
N/A	Painted X Walk1?	Yes	N/A	Painted X Walk2?	Yes
	X Walk 1 Direction	To NE		X Walk 2 Direction	To NW
	X Walk 1 Width (in)	113.0		X Walk 2 Width (in)	114.0
	X Walk 1 Slope (%)	6.6		X Walk 2 Slope (%)	6.4
	X Walk 1 X Slope (%)	4.2		X Walk 2 X Slope (%)	2.1

N/A	Ramp inside XWalk1?	Yes	N/A	Ramp inside XWalk2?	Yes
	Road Slope (%)	1.7		Clear Space?	N/A
	Road X Slope (%)	5.2	N/A	Clear Space to XWalk (in)	N/A
N/A	Any Obstructions?	N/A	N/A	Storm Grate/Utility Hazard?	N/A
	Obstruction Type			Storm Grate/Utility Type	
		N/A			N/A
			Yes	Surface Condition? (G/P)	Good
			No	Curb Slope (%)	6.2

**Remove & Replace Curb Ramp With Two New Directional Ramps or Equivalent.**
