Access Compliance Report

Public Rights-of-Way

(Curb Ramps)

Intersection ID: 5695	Main Street: PARTRIDGE_CROSS_LN	Cross Street: TRAILING_ROCK_DR	Location: S
ADA ID: DF4D26516FD3	Ramp Type: Perp	Initial Pass/Fail: Fail	Overall Compliance: No
Severity Score: 10			
Codes/Mitigation Info/Possible Solution		Field Measurements/Component Compliance

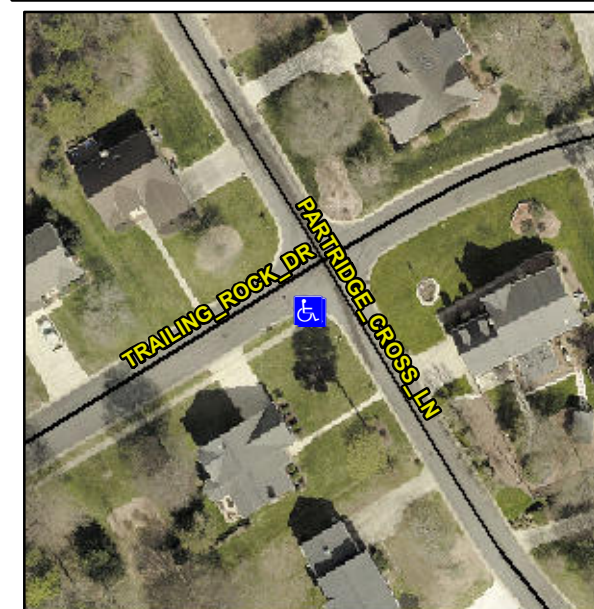
Not Found, R304.5.1, R304.5.3

Compliance	Description	Data	Compliance	Description	Data
N/A	Ramp Length (in)	36.0	Yes	Ramp Slope (%)	6.0
No	Ramp Width (in)	47.5	No	Ramp XSlope (%)	2.3
N/A	Flare Type LT	N/A	N/A	Flare Type RT	N/A
N/A	Flare Slope LT (%)	N/A	N/A	Flare Slope RT (%)	N/A
N/A	Flare Traversable LT?	N/A	N/A	Flare Traversable RT?	N/A
N/A	Landing Length (in)	N/A	N/A	DWS Provided?	N/A
N/A	Landing Width (in)	N/A	N/A	DWS Contrast?	N/A
N/A	Landing Slope (%)	N/A	N/A	DWS Length (in)	N/A
N/A	Landing X Slope (%)	N/A	N/A	DWS Full Width?	N/A
N/A	Landing Curb? (Y/N)	N/A	N/A	DWS Offset (in)	N/A
N/A	Shared Landing?	N/A			
N/A	Gutter Ponding?	N/A	N/A	Gutter Slope (%)	N/A
N/A	Gutter Lip Ht (in)	N/A	N/A	Gutter X Slope (%)	N/A
N/A	Painted X Walk1?	No	N/A	Painted X Walk2?	N/A
	X Walk 1 Direction	To E		X Walk 2 Direction	N/A
N/A	X Walk 1 Width (in)	N/A	N/A	X Walk 2 Width (in)	N/A
	X Walk 1 Slope (%)	2.3		X Walk 2 Slope (%)	N/A
	X Walk 1 X Slope (%)	0.0		X Walk 2 X Slope (%)	N/A

N/A	Ramp inside XWalk1?	N/A	N/A	Ramp inside XWalk2?	N/A
	Road Slope (%)	0.0	N/A	Clear Space?	N/A
	Road X Slope (%)	2.3	N/A	Clear Space to XWalk (in)	N/A
N/A	Any Obstructions?	N/A	N/A	Storm Grate/Utility Hazard?	N/A
	Obstruction Type			Storm Grate/Utility Type	
		N/A			N/A
			Yes	Surface Condition? (G/P)	Good

Possible Solutions:

Remove & Replace Entire Ramp.
