# Access Compliance Report

## Public Rights-of-Way

### (Curb Ramps)

Intersection ID: 20039	Main Street: PROVIDENCE_RD	Cross Street: MAMMOTH_OAKS_DR	Location: NE
ADA ID: DF525C9E4103	Ramp Type: PerpDiag	Initial Pass/Fail: Fail	Overall Compliance: No
		Severity Score: 25

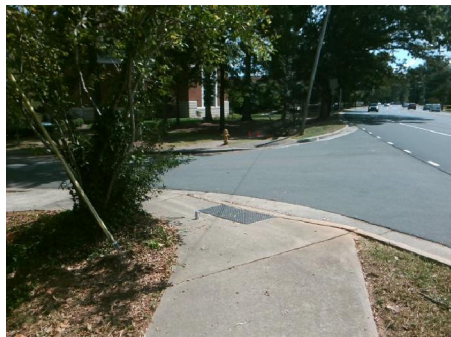
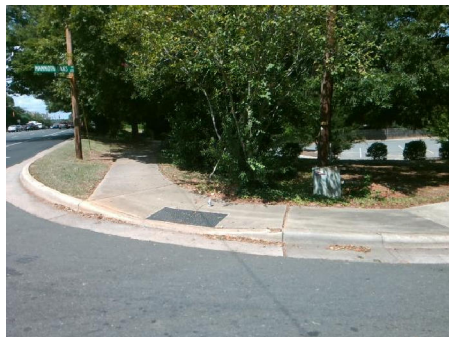
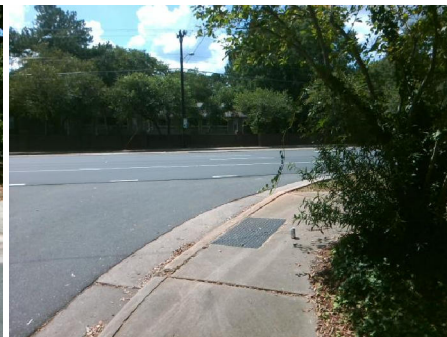
**Not Found, R304.5.3**

Compliance	Description	Data	Compliance	Description	Data
N/A	Ramp Length (in)	58.0	Yes	Ramp Slope (%)	6.7
Yes	Ramp Width (in)	48.0	No	Ramp XSlope (%)	8.0
N/A	Flare Type LT	N/A	N/A	Flare Type RT	N/A
N/A	Flare Slope LT (%)	N/A	N/A	Flare Slope RT (%)	N/A
N/A	Flare Traversable LT?	N/A	N/A	Flare Traversable RT?	N/A
N/A	Landing Length (in)	N/A	N/A	DWS Provided?	N/A
N/A	Landing Width (in)	N/A	N/A	DWS Contrast?	N/A
N/A	Landing Slope (%)	N/A	N/A	DWS Length (in)	N/A
N/A	Landing X Slope (%)	N/A	N/A	DWS Full Width?	N/A
N/A	Landing Curb? (Y/N)	N/A	N/A	DWS Offset (in)	N/A
N/A	Shared Landing?	N/A			
N/A	Gutter Ponding?	N/A	N/A	Gutter Slope (%)	N/A
N/A	Gutter Lip Ht (in)	N/A	N/A	Gutter X Slope (%)	N/A
N/A	Painted X Walk1?	No	N/A	Painted X Walk2?	No
	X Walk 1 Direction	To SW		X Walk 2 Direction	To SE
N/A	X Walk 1 Width (in)	N/A	N/A	X Walk 2 Width (in)	N/A
	X Walk 1 Slope (%)	5.0		X Walk 2 Slope (%)	2.3
	X Walk 1 X Slope (%)	4.8		X Walk 2 X Slope (%)	7.5

N/A	Ramp inside XWalk1?	N/A	N/A	Ramp inside XWalk2?	N/A
	Road Slope (%)	7.0	N/A	Clear Space?	N/A
	Road X Slope (%)	2.9	N/A	Clear Space to XWalk (in)	N/A
N/A	Any Obstructions?	N/A	N/A	Storm Grate/Utility Hazard?	N/A
	Obstruction Type			Storm Grate/Utility Type	
		N/A			N/A
			Yes	Surface Condition? (G/P)	Good

**Remove & Replace Curb Ramp With Two New Directional Ramps or Equivalent.**
