# Access Compliance Report

## Public Rights-of-Way

### (Curb Ramps)

Intersection ID: 28977	Main Street: BANNINGTON_RD	Cross Street: BEROLINA_LN	Location: NW
ADA ID: DF5973BFA7DB	Ramp Type: PerpDiag	Initial Pass/Fail: Fail	Overall Compliance: No
Severity Score: 33.75			
Codes/Mitigation Info/Possible Solution		Field Measurements/Component Compliance

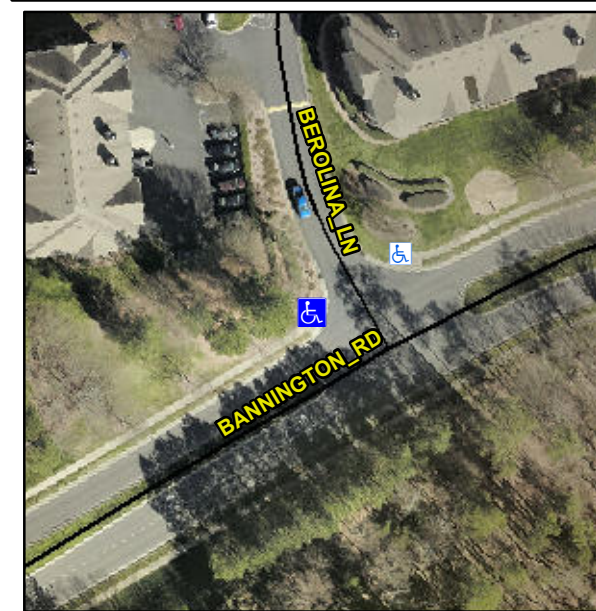
**Not Found, R304.5.1, R304.5.3**

Compliance	Description	Data	Compliance	Description	Data
N/A	Ramp Length (in)	93.0	Yes	Ramp Slope (%)	5.7
No	Ramp Width (in)	41.5	No	Ramp XSlope (%)	8.9
N/A	Flare Type LT	N/A	N/A	Flare Type RT	N/A
N/A	Flare Slope LT (%)	N/A	N/A	Flare Slope RT (%)	N/A
N/A	Flare Traversable LT?	N/A	N/A	Flare Traversable RT?	N/A
N/A	Landing Length (in)	N/A	N/A	DWS Provided?	N/A
N/A	Landing Width (in)	N/A	N/A	DWS Contrast?	N/A
N/A	Landing Slope (%)	N/A	N/A	DWS Length (in)	N/A
N/A	Landing X Slope (%)	N/A	N/A	DWS Full Width?	N/A
N/A	Landing Curb? (Y/N)	N/A	N/A	DWS Offset (in)	N/A
N/A	Shared Landing?	N/A			
N/A	Gutter Ponding?	N/A	N/A	Gutter Slope (%)	N/A
N/A	Gutter Lip Ht (in)	N/A	N/A	Gutter X Slope (%)	N/A
N/A	Painted X Walk1?	No	N/A	Painted X Walk2?	No
	X Walk 1 Direction	To S		X Walk 2 Direction	To E
N/A	X Walk 1 Width (in)	N/A	N/A	X Walk 2 Width (in)	N/A
	X Walk 1 Slope (%)	2.6		X Walk 2 Slope (%)	4.8
	X Walk 1 X Slope (%)	5.1		X Walk 2 X Slope (%)	2.9

N/A	Ramp inside XWalk1?	N/A	N/A	Ramp inside XWalk2?	N/A
	Road Slope (%)	7.0	N/A	Clear Space?	N/A
	Road X Slope (%)	2.9	N/A	Clear Space to XWalk (in)	N/A
N/A	Any Obstructions?	N/A	N/A	Storm Grate/Utility Hazard?	N/A
	Obstruction Type			Storm Grate/Utility Type	
		N/A			N/A
			Yes	Surface Condition? (G/P)	Good

**Remove & Replace Curb Ramp With Two New Directional Ramps or Equivalent.**

Total Cost: \$ 3200.00
