Access Compliance Report Public Rights-of-Way (Curb Ramps)

Intersection ID: 9594 Main Street: CADMIUM_CT Cross Street: MOODY_RD Location: SE

Overall Compliance: No ADA ID: DF7001C30092 Ramp Type: Perp Initial Pass/Fail: Fail **Severity Score:** 1.25

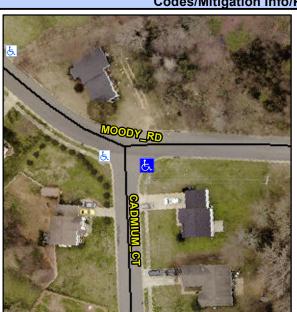
Field Measurements/Component Compliance								
Comp	Compliance Description		Comp	liance Description	Data			
N/A	Ramp Length (in)	46.5	Yes	Ramp Slope (%)	6.4			
Yes	Ramp Width (in)	54.0	No	Ramp XSlope (%)	4.3			
N/A	Flare Type LT	N/A	N/A	Flare Type RT	N/A			
N/A	Flare Slope LT (%)	N/A	N/A	Flare Slope RT (%)	N/A			
N/A	Flare Traversable LT?	N/A	N/A	Flare Traversable RT?	N/A			
N/A	Landing Length (in)	N/A	N/A	DWS Provided?	N/A			
N/A	Landing Width (in)	N/A	N/A	DWS Contrast?	N/A			
N/A	Landing Slope (%)	N/A	N/A	DWS Length (in)	N/A			
N/A	Landing X Slope (%)	N/A	N/A	DWS Full Width?	N/A			
N/A	Landing Curb? (Y/N)	N/A	N/A	DWS Offset (in)	N/A			
N/A	Shared Landing?	N/A						
N/A	Gutter Ponding?	N/A	N/A	Gutter Slope (%)	N/A			
N/A	Gutter Lip Ht (in)	N/A	N/A	Gutter X Slope (%)	N/A			
N/A	Painted X Walk1?	No	N/A	Painted X Walk2?	N/A			
	X Walk 1 Direction	To NW		X Walk 2 Direction	N/A			
N/A	X Walk 1 Width (in)	N/A	N/A	X Walk 2 Width (in)	N/A

X Walk 1 Slope (%)	1.6		X Walk 2 Slope (%)	N/A			
	X Walk 1 X Slope (%)	5.6		X Walk 2 X Slope (%)	N/A			
N/A	Ramp inside XWalk1?	N/A	N/A	Ramp inside XWalk2?	N/A			
	Road Slope (%)	N/A	N/A	Clear Space?	N/A			
	Road X Slope (%)	N/A	N/A	Clear Space to XWalk (in)	N/A			
N/A	Any Obstructions?	N/A	N/A	Storm Grate/Utility Hazard?	N/A			
	Obstruction Type			Storm Grate/Utility Type				
		N/A			N/A			
			Yes	Surface Condition? (G/P)	Good

_	71 COSIDIC COIGUOII	
No.	Possible Solutions:	Cor
	Remove & Replace Entire Ramp.	N/A
		Yes
		N/A
Š		N/A
		N/A
ā		N/A
	Surveyor Notes:	N/A
	N/A	N/A
ř		N/A
		N/A
1		N/A
	PROW/ADA:	N/A
	Not Found, R304.5.3	N/A
-	, , , , , , , , , , , , , , , , , , , ,	N/A
STATE OF		N/A
		N/A

Total Cost: 1850.00
