## Access Compliance Report Public Rights-of-Way (Curb Ramps)

Intersection ID: 21454 Main Street: SARDIS\_RD\_NORTH Cross Street: MAPLE\_SHADE\_LN Location: NE

ADA ID: DF8B2688B65B Ramp Type: PerpDiag Initial Pass/Fail: Fail Overall Compliance: No Severity Score: 37.5

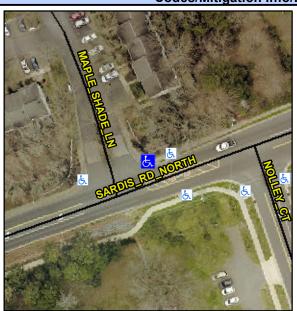
| Field Measurements/Component Compliance | | | | | |
|---|---|---|---|---|---|
| N/A | Ramp Length (in) | 59.0 | No | Ramp Slope (%) | 9.0 |
| Yes | Ramp Width (in) | 48.0 | No | Ramp XSlope (%) | 9.7 |

MAPLE SHADE LN StopSign SARDIS RD NORTH None Possible Solutions:

Remove & Replace Curb Ramp With
Two New Directional Ramps or
Equivalent.

PROW/ADA:
R304.2.2, R304.5.3
