Access Compliance Report Public Rights-of-Way (Curb Ramps)

Intersection ID: 7036
 Main Street:
 BEATTIES_FORD_RD
 Cross Street:
 MCALLISTER_DR
 Location:
 NW

ADA ID: DF954A74ADC7
 Ramp Type:
 PerpDiag
 Initial Pass/Fail:
 Fail
 Overall Compliance:
 No
 Severity Score:
 10

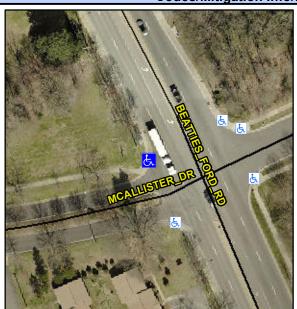
Not Found, R304.5.1, R304.5.3

| Field Measurements/Component Compliance | | | | | | |
|---|---|---|---|---|---|---|
| | N/A | Ramp Length (in) | 61.0 | Yes | Ramp Slope (%) | 7.6 |
| | No | Ramp Width (in) | 42.5 | No | Ramp XSlope (%) | 3.0 |

Remove & Replace Curb Ramp With Two New Directional Ramps or Equivalent.
