Access Compliance Report

Public Rights-of-Way

(Curb Ramps)

Intersection ID: 6113	Main Street: PURSLANE_CT	Cross Street: YARROW_RD	Location:	W
ADA ID: DFA0CFBDD895	Ramp Type: Perp	Initial Pass/Fail: Fail	Overall Compliance: No	Severity Score: 10

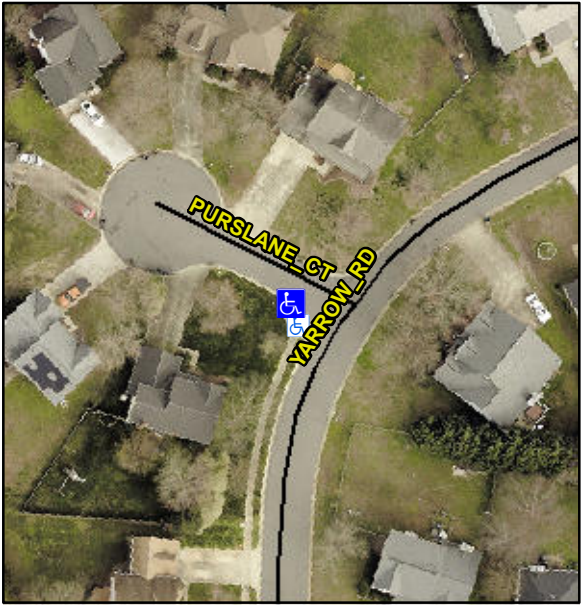
Possible Solutions:		Compliance	Description	Data
	Remove & Replace Entire Ramp.		Yes	Ramp Length (in)	46.0
			No	Ramp Width (in)	47.0
			N/A	Flare Type LT	N/A
			N/A	Flare Slope LT (%)	N/A
			N/A	Flare Traversable LT?	N/A
			N/A	Landing Length (in)	N/A
			N/A	Landing Width (in)	N/A
			N/A	Landing Slope (%)	N/A
			N/A	Landing X Slope (%)	N/A
<p>Surveyor Notes:</p> <p>N/A</p> <p>PROW/ADA:</p> <p>Not Found, R304.5.1, R304.5.3</p>			N/A	Flare Type RT	N/A
			N/A	Flare Slope RT (%)	N/A
			N/A	Flare Traversable RT?	N/A
			N/A	DWS Provided?	N/A
			N/A	DWS Contrast?	N/A
			N/A	DWS Length (in)	N/A
			N/A	DWS Full Width?	N/A
			N/A	DWS Offset (in)	N/A
			N/A	Gutter Ponding?	N/A
			N/A	Gutter Lip Ht (in)	1.0
			No	Painted X Walk1?	N/A
				X Walk 1 Direction	To NE
			N/A	X Walk 1 Width (in)	N/A
				X Walk 1 Slope (%)	0.7
				X Walk 1 X Slope (%)	4.0

N/A	Ramp inside XWalk1?	N/A
			N/A	Road Slope (%)	N/A
			N/A	Road X Slope (%)	N/A
			N/A	Any Obstructions?	N/A
				Obstruction Type	
Total Cost:		\$ 1850.00	N/A	Storm Grate/Utility Hazard?	N/A
				Storm Grate/Utility Type	
			N/A		N/A
			Yes	Surface Condition? (G/P)	Good
