Access Compliance Report

Public Rights-of-Way

(Curb Ramps)

Intersection ID: 47920	Main Street: RINGNECK_RD	Cross Street: ROOK_RD	Location:	N
ADA ID: DFA51135AD5C	Ramp Type: PerpDiag	Initial Pass/Fail: Fail	Overall Compliance: No	Severity Score: 10

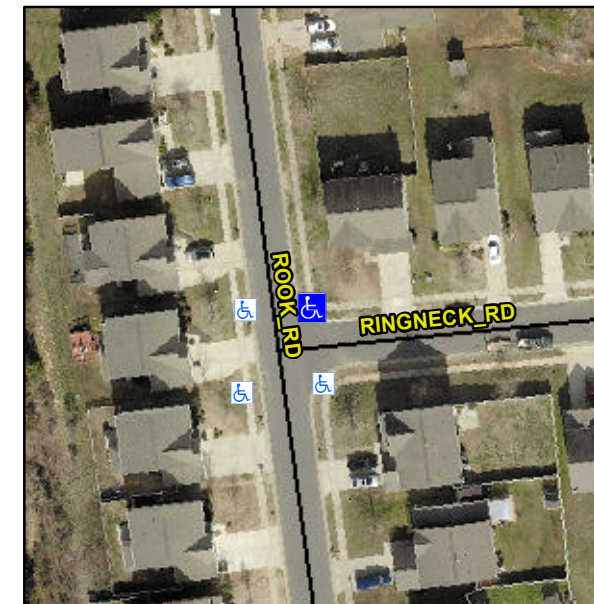
Not Found, R304.5.1, R304.5.3

Compliance	Description	Data	Compliance	Description	Data
N/A	Ramp Length (in)	47.5	Yes	Ramp Slope (%)	7.9
No	Ramp Width (in)	47.0	No	Ramp XSlope (%)	4.5
N/A	Flare Type LT	N/A	N/A	Flare Type RT	N/A
N/A	Flare Slope LT (%)	N/A	N/A	Flare Slope RT (%)	N/A
N/A	Flare Traversable LT?	N/A	N/A	Flare Traversable RT?	N/A
N/A	Landing Length (in)	N/A	N/A	DWS Provided?	N/A
N/A	Landing Width (in)	N/A	N/A	DWS Contrast?	N/A
N/A	Landing Slope (%)	N/A	N/A	DWS Length (in)	N/A
N/A	Landing X Slope (%)	N/A	N/A	DWS Full Width?	N/A
N/A	Landing Curb? (Y/N)	N/A	N/A	DWS Offset (in)	N/A
N/A	Shared Landing?	N/A			
N/A	Gutter Ponding?	N/A	N/A	Gutter Slope (%)	N/A
N/A	Gutter Lip Ht (in)	N/A	N/A	Gutter X Slope (%)	N/A
N/A	Painted X Walk1?	No	N/A	Painted X Walk2?	No
	X Walk 1 Direction	To W		X Walk 2 Direction	To S
N/A	X Walk 1 Width (in)	N/A	N/A	X Walk 2 Width (in)	N/A
	X Walk 1 Slope (%)	1.1		X Walk 2 Slope (%)	4.0
	X Walk 1 X Slope (%)	3.0		X Walk 2 X Slope (%)	0.2

N/A	Ramp inside XWalk1?	N/A	N/A	Ramp inside XWalk2?	N/A
	Road Slope (%)	3.5	N/A	Clear Space?	N/A
	Road X Slope (%)	2.3	N/A	Clear Space to XWalk (in)	N/A
N/A	Any Obstructions?	N/A	N/A	Storm Grate/Utility Hazard?	N/A
	Obstruction Type			Storm Grate/Utility Type	
		N/A			N/A
			Yes	Surface Condition? (G/P)	Good

Remove & Replace Curb Ramp With Two New Directional Ramps or Equivalent.
