# Access Compliance Report

## Public Rights-of-Way

### (Curb Ramps)

Intersection ID: 31747	Main Street: LEAF_PLUM_DR	Cross Street: WASHOE_PINE_LN	Location: NW
ADA ID: DFA61112A875	Ramp Type: PerpDiag	Initial Pass/Fail: Fail	Overall Compliance: No
Severity Score: 46.25			
Codes/Mitigation Info/Possible Solution		Field Measurements/Component Compliance

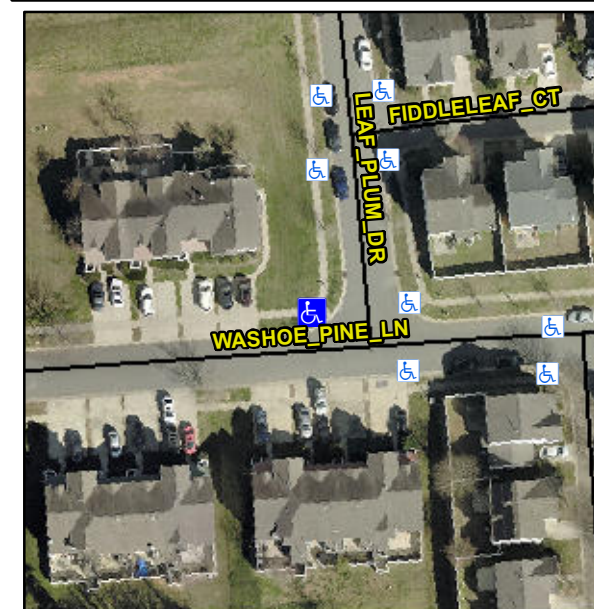
**Not Found, R304.5.1, R304.2.2, R304.5.3**

Compliance	Description	Data	Compliance	Description	Data
N/A	Ramp Length (in)	85.5	No	Ramp Slope (%)	8.9
No	Ramp Width (in)	47.5	No	Ramp XSlope (%)	9.5
N/A	Flare Type LT	N/A	N/A	Flare Type RT	N/A
N/A	Flare Slope LT (%)	N/A	N/A	Flare Slope RT (%)	N/A
N/A	Flare Traversable LT?	N/A	N/A	Flare Traversable RT?	N/A
N/A	Landing Length (in)	N/A	N/A	DWS Provided?	N/A
N/A	Landing Width (in)	N/A	N/A	DWS Contrast?	N/A
N/A	Landing Slope (%)	N/A	N/A	DWS Length (in)	N/A
N/A	Landing X Slope (%)	N/A	N/A	DWS Full Width?	N/A
N/A	Landing Curb? (Y/N)	N/A	N/A	DWS Offset (in)	N/A
N/A	Shared Landing?	N/A			
N/A	Gutter Ponding?	N/A	N/A	Gutter Slope (%)	N/A
N/A	Gutter Lip Ht (in)	N/A	N/A	Gutter X Slope (%)	N/A
N/A	Painted X Walk1?	No	N/A	Painted X Walk2?	No
	X Walk 1 Direction	To S		X Walk 2 Direction	To E
N/A	X Walk 1 Width (in)	N/A	N/A	X Walk 2 Width (in)	N/A
	X Walk 1 Slope (%)	2.3		X Walk 2 Slope (%)	6.8
	X Walk 1 X Slope (%)	6.5		X Walk 2 X Slope (%)	3.2

N/A	Ramp inside XWalk1?	N/A	N/A	Ramp inside XWalk2?	N/A
	Road Slope (%)	6.8	N/A	Clear Space?	N/A
	Road X Slope (%)	2.2	N/A	Clear Space to XWalk (in)	N/A
N/A	Any Obstructions?	N/A	N/A	Storm Grate/Utility Hazard?	N/A
	Obstruction Type			Storm Grate/Utility Type	
		N/A			N/A
			Yes	Surface Condition? (G/P)	Good

**Remove & Replace Curb Ramp With Two New Directional Ramps or Equivalent.**
