# Access Compliance Report

## Public Rights-of-Way

### (Curb Ramps)

Intersection ID: 5317	Main Street: OLD_STATESVILLE_RD	Cross Street: OAK_DR	Location:	N
ADA ID: DFB5AD1AD80D	Ramp Type: Perp	Initial Pass/Fail: Fail	Overall Compliance: No	Severity Score: 8.75
Codes/Mitigation Info/Possible Solution		Field Measurements/Component Compliance

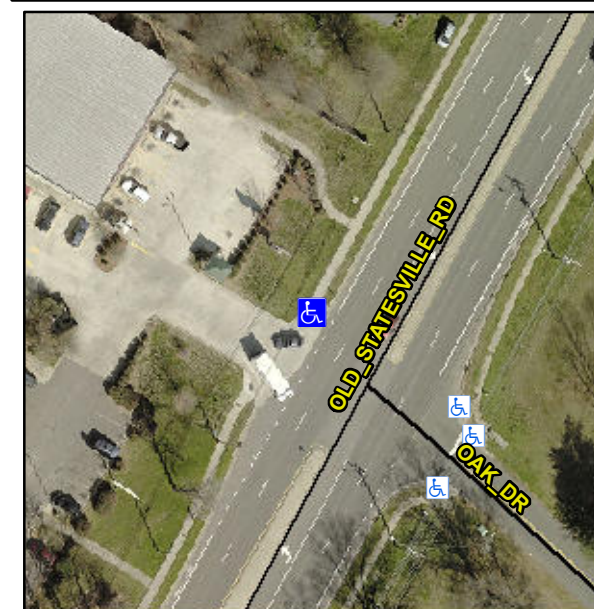
Compliance	Description	Data	Compliance	Description	Data
N/A	Ramp Length (in)	56.5	Yes	Ramp Slope (%)	7.7
No	Ramp Width (in)	47.0	Yes	Ramp XSlope (%)	1.2
N/A	Flare Type LT	N/A	N/A	Flare Type RT	N/A
N/A	Flare Slope LT (%)	N/A	N/A	Flare Slope RT (%)	N/A
N/A	Flare Traversable LT?	N/A	N/A	Flare Traversable RT?	N/A
N/A	Landing Length (in)	N/A	N/A	DWS Provided?	N/A
N/A	Landing Width (in)	N/A	N/A	DWS Contrast?	N/A
N/A	Landing Slope (%)	N/A	N/A	DWS Length (in)	N/A
N/A	Landing X Slope (%)	N/A	N/A	DWS Full Width?	N/A
N/A	Landing Curb? (Y/N)	N/A	N/A	DWS Offset (in)	N/A
N/A	Shared Landing?	N/A			
N/A	Gutter Ponding?	N/A	N/A	Gutter Slope (%)	N/A
N/A	Gutter Lip Ht (in)	N/A	N/A	Gutter X Slope (%)	N/A
N/A	Painted X Walk1?	No	N/A	Painted X Walk2?	N/A
	X Walk 1 Direction	To E		X Walk 2 Direction	N/A
N/A	X Walk 1 Width (in)	N/A	N/A	X Walk 2 Width (in)	N/A
	X Walk 1 Slope (%)	0.4		X Walk 2 Slope (%)	N/A
	X Walk 1 X Slope (%)	0.6		X Walk 2 X Slope (%)	N/A

N/A	Ramp inside XWalk1?	N/A	N/A	Ramp inside XWalk2?	N/A
	Road Slope (%)	N/A	N/A	Clear Space?	N/A
	Road X Slope (%)	N/A	N/A	Clear Space to XWalk (in)	N/A
N/A	Any Obstructions?	N/A	N/A	Storm Grate/Utility Hazard?	N/A
	Obstruction Type			Storm Grate/Utility Type	
		N/A			N/A
			Yes	Surface Condition? (G/P)	Good

Possible Solutions:

**Remove & Replace Entire Ramp.**

**R304.5.1**

Total Cost: \$ 1850.00
