Access Compliance Report Public Rights-of-Way (Curb Ramps)

Intersection ID: 10024281 Main Street: CRANBROOK_LN Cross Street: N/A Location: E

ADA ID: DFBE83043451 Ramp Type: PerpDiag Initial Pass/Fail: Fail Overall Compliance: No Severity Score: 46.25

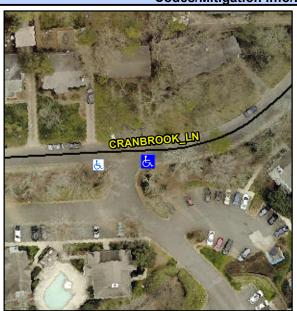
Field Measurements/Component Compliance					
Compliance Description		Data	Compliance Description		Data
N/A	Ramp Length (in)	38.0	No	Ramp Slope (%)	14.9
No	Ramp Width (in)	38.0	No	Ramp XSlope (%)	5.2
N/A	Flare Type LT	N/A	N/A	Flare Type RT	N/A
N/A	Flare Slope LT (%)	N/A	N/A	Flare Slope RT (%)	N/A
N/A	Flare Traversable LT?	N/A	N/A	Flare Traversable RT?	N/A
N/A	Landing Length (in)	N/A	N/A	DWS Provided?	N/A
N/A	Landing Width (in)	N/A	N/A	DWS Contrast?	N/A
N/A	Landing Slope (%)	N/A	N/A	DWS Length (in)	N/A
N/A	Landing X Slope (%)	N/A	N/A	DWS Full Width?	N/A
N/A	Landing Curb? (Y/N)	N/A	N/A	DWS Offset (in)	N/A
N/A	Shared Landing?	N/A			
N/A	Gutter Ponding?	N/A	N/A	Gutter Slope (%)	N/A
N/A	Gutter Lip Ht (in)	N/A	N/A	Gutter X Slope (%)	N/A
N/A	Painted X Walk1?	No	N/A	Painted X Walk2?	No
	X Walk 1 Direction	To N		X Walk 2 Direction	To W
N/A	X Walk 1 Width (in)	N/A	N/A	X Walk 2 Width (in)	N/A
	X Walk 1 Slope (%)	0.5		X Walk 2 Slope (%)	4.0

X Walk 1 X Slope (%)	3.0		X Walk 2 X Slope (%)	4.4
N/A	Ramp inside XWalk1?	N/A	N/A	Ramp inside XWalk2?	N/A
	Road Slope (%)	0.5	N/A	Clear Space?	N/A
	Road X Slope (%)	7.7	N/A	Clear Space to XWalk (in)	N/A
N/A	Any Obstructions?	N/A	N/A	Storm Grate/Utility Hazard?	N/A
	Obstruction Type			Storm Grate/Utility Type	
		N/A			N/A
			Yes	Surface Condition? (G/P)	Good

Remove & Replace Curb Ramp With
Two New Directional Ramps or
Equivalent.

R304.5.1, R304.2.2, R304.5.3

N/A
Total Cost:
\$ 3200.00
