Access Compliance Report

Public Rights-of-Way

(Curb Ramps)

Intersection ID: 52768	Main Street: SHOPTON_RD	Cross Street: NEW_FASHION_WY	Location: SW
ADA ID: DFC14EDE8DAB	Ramp Type: Perp	Initial Pass/Fail: Fail	Overall Compliance: No
Severity Score: 21.25			
Codes/Mitigation Info/Possible Solution		Field Measurements/Component Compliance

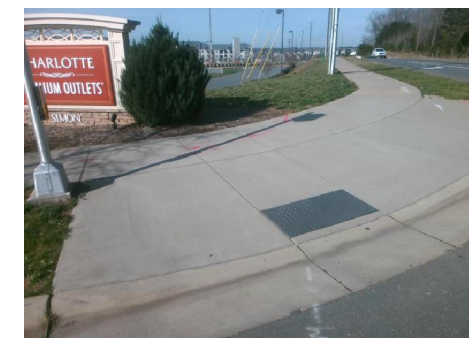
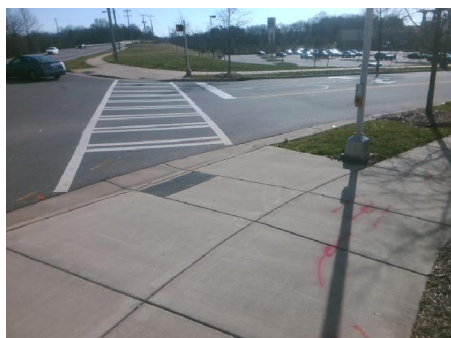
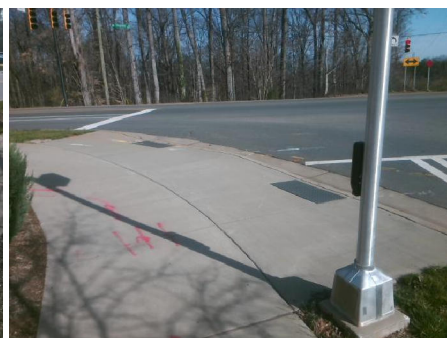
Not Found, R304.5.1, R304.5.3

Compliance	Description	Data	Compliance	Description	Data
N/A	Ramp Length (in)	95.0	Yes	Ramp Slope (%)	7.0
No	Ramp Width (in)	47.0	No	Ramp XSlope (%)	5.5
N/A	Flare Type LT	N/A	N/A	Flare Type RT	N/A
N/A	Flare Slope LT (%)	N/A	N/A	Flare Slope RT (%)	N/A
N/A	Flare Traversable LT?	N/A	N/A	Flare Traversable RT?	N/A
N/A	Landing Length (in)	N/A	N/A	DWS Provided?	N/A
N/A	Landing Width (in)	N/A	N/A	DWS Contrast?	N/A
N/A	Landing Slope (%)	N/A	N/A	DWS Length (in)	N/A
N/A	Landing X Slope (%)	N/A	N/A	DWS Full Width?	N/A
N/A	Landing Curb? (Y/N)	N/A	N/A	DWS Offset (in)	N/A
N/A	Shared Landing?	N/A			
N/A	Gutter Ponding?	N/A	N/A	Gutter Slope (%)	N/A
N/A	Gutter Lip Ht (in)	N/A	N/A	Gutter X Slope (%)	N/A
N/A	Painted X Walk1?	Yes	N/A	Painted X Walk2?	N/A
	X Walk 1 Direction	To E		X Walk 2 Direction	N/A
N/A	X Walk 1 Width (in)	120.0	N/A	X Walk 2 Width (in)	N/A
	X Walk 1 Slope (%)	1.9		X Walk 2 Slope (%)	N/A
	X Walk 1 X Slope (%)	6.9		X Walk 2 X Slope (%)	N/A

N/A	Ramp inside XWalk1?	Yes	N/A	Ramp inside XWalk2?	N/A
	Road Slope (%)	N/A	N/A	Clear Space?	N/A
	Road X Slope (%)	N/A	N/A	Clear Space to XWalk (in)	N/A
N/A	Any Obstructions?	N/A	N/A	Storm Grate/Utility Hazard?	N/A
	Obstruction Type			Storm Grate/Utility Type	
		N/A			N/A
		Yes		Surface Condition? (G/P)	Good

Possible Solutions:

Remove & Replace Entire Ramp.

Total Cost: \$ 1850.00
