Access Compliance Report Public Rights-of-Way (Curb Ramps)

Intersection ID: 13228 Main Stu	Main Street: CENTRAL_AV		Cross Street: LANDIS AV				SW
			Initial Pass/Fail: Fail Overall Compliance: No			Location: Severity Score:	
Codes/Mitigation Info/Possible Solution		Field Measurements/Component Compliance					
Possible Solutions:		· · · · · ·					Data
		<u>0011</u> N/A	Ramp Length (in)		No	Ramp Slope (%)	14.3
	Remove & Replace Entire Ramp.	No	Ramp Width (in)		Yes	Ramp XSlope (%)	1.5
		N/A	Flare Type LT		N/A	Flare Type RT	N/A
		N/A	Flare Slope LT (%)		N/A	Flare Slope RT (%)	N/A
		N/A	Flare Traversable LT?		N/A	Flare Traversable RT?	N/A
		N/A N/A			N/A N/A	DWS Provided?	N/A N/A
CENURAL_AV	Cumunum Natan		Landing Length (in)		N/A		
	Surveyor Notes:	N/A	Landing Width (in)			DWS Contrast?	N/A

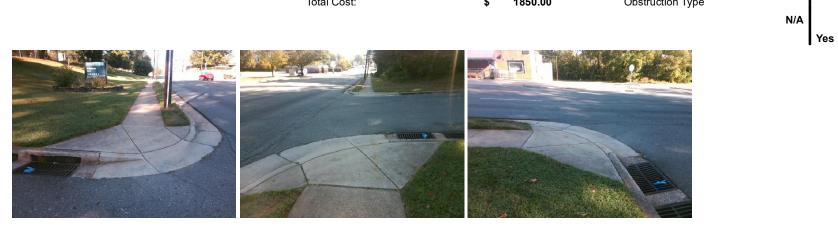
G. G.	N/A	N/A	Landing Slope (%)		N/A	DWS Length (in)	N/A
		N/A	Landing X Slope (%)		N/A	DWS Full Width?	N/A
		N/A	Landing Curb? (Y/N)		N/A	DWS Offset (in)	N/A
		N/A	Shared Landing?	N/A			
The second s	PROW/ADA:	N/A	Gutter Ponding?	N/A	N/A	Gutter Slope (%)	N/A
	Not Found, R304.5.1, R304.2.2	N/A	Gutter Lip Ht (in)	N/A	N/A	Gutter X Slope (%)	N/A
The All States and the second states		N/A	Painted X Walk1?	No	N/A	Painted X Walk2?	N/A
			X Walk 1 Direction	To E		X Walk 2 Direction	N/A
		N/A	X Walk 1 Width (in)	N/A	N/A	X Walk 2 Width (in)	N/A
Street 1 Name LANDIS AV			X Walk 1 Slope (%)	1.0		X Walk 2 Slope (%)	N/A
Stop Condition-Street 2 None			X Walk 1 X Slope (%)	2.0		X Walk 2 X Slope (%)	N/A
Street 2 Name N/A		N/A	Ramp inside XWalk1?	N/A	N/A	Ramp inside XWalk2?	N/A
Stop Condition-Street 1 N/A			Road Slope (%)	N/A	N/A	Clear Space?	N/A
			Road X Slope (%)	N/A	N/A	Clear Space to XWalk (in)	N/A
		N/A	Any Obstructions?	N/A	N/A	Storm Grate/Utility Hazard?	N/A

Total Cost: \$ 1	850.00	Obstruction Type			Storm Grate/Utility Type	
	•		51	N/A			N/A
