## Access Compliance Report Public Rights-of-Way (Curb Ramps)

Intersection ID: 48562Main Street: HAINES\_MILL\_RDCross Street: SHOPTON\_RDLocation:SWADA ID: DFCEFF9937B0Ramp Type: PerpDiagInitial Pass/Fail: FailOverall Compliance: NoSeverity Score:25

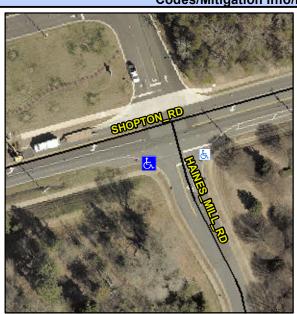
Fleid Measurements/Component Compnance						
	Compliance Description		Data	Data Compliance Description		Data
	N/A	Ramp Length (in)	60.0	Yes	Ramp Slope (%)	8.0
	Yes	Ramp Width (in)	48.0	No	Ramp XSlope (%)	8.5
	N/A	Flare Type LT	N/A	N/A	Flare Type RT	N/A
	N/A	Flare Slope LT (%)	N/A	N/A	Flare Slope RT (%)	N/A
	N/A	Flare Traversable LT?	N/A	N/A	Flare Traversable RT?	N/A
	N/A	Landing Length (in)	N/A	N/A	DWS Provided?	N/A
	N/A	Landing Width (in)	N/A	N/A	DWS Contrast?	N/A
	N/A	Landing Slope (%)	N/A	N/A	DWS Length (in)	N/A
	N/A	Landing X Slope (%)	N/A	N/A	DWS Full Width?	N/A
	N/A	Landing Curb? (Y/N)	N/A	N/A	DWS Offset (in)	N/A
	N/A	Shared Landing?	N/A			
	N/A	Gutter Ponding?	N/A	N/A	Gutter Slope (%)	N/A
	N/A	Gutter Lip Ht (in)	N/A	N/A	Gutter X Slope (%)	N/A
	N/A	Painted X Walk1?	No	N/A	Painted X Walk2?	No
		X Walk 1 Direction	То Е		X Walk 2 Direction	To N
	N/A	X Walk 1 Width (in)	N/A	N/A	X Walk 2 Width (in)	N/A
		X Walk 1 Slope (%)	3.0		X Walk 2 Slope (%)	0.4

X Walk 1 X Slope (%)	1.1		X Walk 2 X Slope (%)	3.2
	N/A	Ramp inside XWalk1?	N/A	N/A	Ramp inside XWalk2?	N/A
		Road Slope (%)	1.9	N/A	Clear Space?	N/A
		Road X Slope (%)	1.6	N/A	Clear Space to XWalk (in)	N/A
	N/A	Any Obstructions?	N/A	N/A	Storm Grate/Utility Hazard?	N/A
		Obstruction Type			Storm Grate/Utility Type	
			N/A			N/A
				Yes	Surface Condition? (G/P)	Good

Possible Solutions:

Remove & Replace Curb Ramp With
Two New Directional Ramps or
Equivalent.
