Access Compliance Report

Public Rights-of-Way

(Curb Ramps)

Intersection ID: 7523	Main Street: COTTONWOOD_ST	Cross Street: N_GRAHAM_ST	Location: E
ADA ID: DFD05346A23A	Ramp Type: Para	Initial Pass/Fail: Pass	Overall Compliance: No
Codes/Mitigation Info/Possible Solution		Field Measurements/Component Compliance	
Severity Score: 2.75

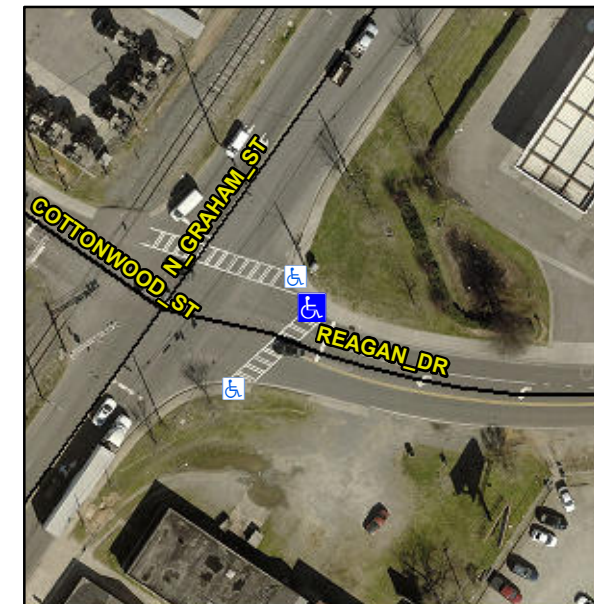
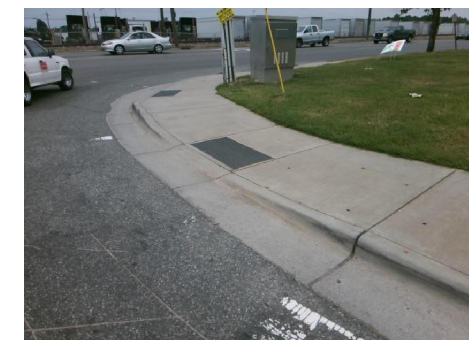
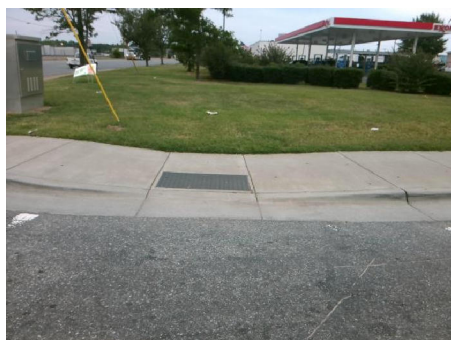
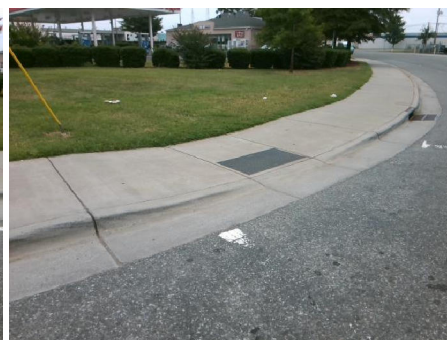
Compliance	Description	Data	Compliance	Description	Data
N/A	Ramp Length LT (in)	63.5	N/A	Ramp Length RT (in)	66.0
Yes	Ramp Width LT (in)	71.0	Yes	Ramp Width RT (in)	72.0
Yes	Ramp Slope LT (%)	6.5	Yes	Ramp Slope RT (%)	5.4
No	Ramp XSlope LT (%)	2.6	Yes	Ramp XSlope RT (%)	1.8
Yes	Landing Length (in)	71.5	Yes	DWS Provided?	Yes
Yes	Landing Width (in)	50.5	Yes	DWS Contrast?	Yes
Yes	Landing Slope (%)	1.2	Yes	DWS Length (in)	24.0
Yes	Landing X Slope (%)	1.2	No	DWS Full Width?	No
N/A	Landing Curb? (Y/N)	No	No	DWS Offset (in)	3.0
N/A	Shared Landing?	No			
Yes	Gutter Ponding?	No	Yes	Gutter Slope (%)	1.5
Yes	Gutter Lip Ht (in)	0.0	Yes	Gutter X Slope (%)	0.8
N/A	Painted X Walk1?	No	N/A	Painted X Walk2?	N/A
	X Walk 1 Direction	To SW		X Walk 2 Direction	N/A
N/A	X Walk 1 Width (in)	N/A	N/A	X Walk 2 Width (in)	N/A
	X Walk 1 Slope (%)	3.8		X Walk 2 Slope (%)	N/A
	X Walk 1 X Slope (%)	1.9		X Walk 2 X Slope (%)	N/A
N/A	Ramp inside XWalk1?	N/A	N/A	Ramp inside XWalk2?	N/A

Road Slope (%)	N/A	N/A	Clear Space?	Yes
	Road X Slope (%)	N/A	N/A	Clear Space to XWalk (in)	N/A
Yes	Any Obstructions?	No	Yes	Storm Grate/Utility Hazard?	No
	Obstruction Type			Storm Grate/Utility Type	
		N/A			N/A
			Yes	Surface Condition? (G/P)	Good
			N/A	Curb Slope (%)	25.4

Possible Solutions:

Remove & Replace Entire Ramp.

R304.5.3, R305.1.4, R305.2
