# Access Compliance Report

## Public Rights-of-Way

### (Curb Ramps)

Intersection ID: 10649	Main Street: MARTIN_ST	Cross Street: N_SUMMIT_AV	Location: SW
ADA ID: DFD4DDDAFE6F	Ramp Type: PerpDiag	Initial Pass/Fail: Fail	Overall Compliance: No
			Severity Score: 21.25

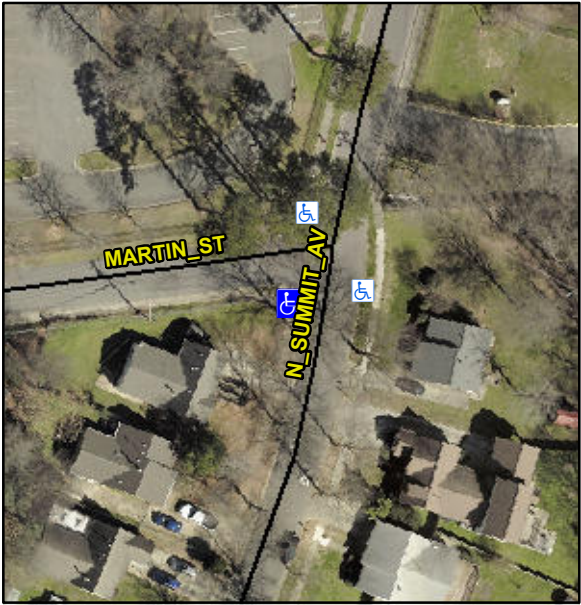
Possible Solutions:		<b>Compliance</b>	<b>Description</b>	<b>Data</b>
	<b>Remove &amp; Replace Curb Ramp With Two New Directional Ramps or Equivalent.</b>		<b>Yes</b>	Ramp Length (in)	70.5
			<b>No</b>	Ramp Width (in)	46.5
			<b>N/A</b>	Flare Type LT	N/A
			<b>N/A</b>	Flare Slope LT (%)	N/A
			<b>N/A</b>	Flare Traversable LT?	N/A
			<b>N/A</b>	Landing Length (in)	N/A
			<b>N/A</b>	Landing Width (in)	N/A
			<b>N/A</b>	Landing Slope (%)	N/A
			<b>N/A</b>	Landing X Slope (%)	N/A
			<b>N/A</b>	Landing Curb? (Y/N)	N/A
			<b>N/A</b>	Shared Landing?	N/A
			<b>N/A</b>	Gutter Ponding?	N/A
			<b>N/A</b>	Gutter Lip Ht (in)	1.5
			<b>No</b>	Painted X Walk1?	No
				X Walk 1 Direction	To E
			<b>N/A</b>	X Walk 1 Width (in)	N/A
				X Walk 1 Slope (%)	1.4
				X Walk 1 X Slope (%)	6.8
			<b>N/A</b>	Ramp inside XWalk1?	N/A
<p>Surveyor Notes:</p> <p><b>N/A</b></p> <p>PROW/ADA:</p> <p><b>Not Found, R304.5.1, R304.5.3</b></p>			<b>N/A</b>	Flare Type RT	N/A

<b>N/A</b>	Flare Slope RT (%)	N/A
			<b>N/A</b>	Flare Traversable RT?	N/A
			<b>N/A</b>	DWS Provided?	N/A
			<b>N/A</b>	DWS Contrast?	N/A
			<b>N/A</b>	DWS Length (in)	N/A
			<b>N/A</b>	DWS Full Width?	N/A
			<b>N/A</b>	DWS Offset (in)	N/A
			<b>N/A</b>	Gutter Slope (%)	N/A
			<b>N/A</b>	Gutter X Slope (%)	N/A
			<b>N/A</b>	Painted X Walk2?	No
				X Walk 2 Direction	To NE
			<b>N/A</b>	X Walk 2 Width (in)	N/A
				X Walk 2 Slope (%)	8.2
				X Walk 2 X Slope (%)	4.3
			<b>N/A</b>	Ramp inside XWalk2?	N/A
			<b>N/A</b>	Clear Space?	N/A
			<b>N/A</b>	Clear Space to XWalk (in)	N/A
			<b>N/A</b>	Storm Grate/Utility Hazard?	N/A
				Storm Grate/Utility Type	
<p>Total Cost:</p> <p>\$ 3200.00</p>			<b>N/A</b>		<b>N/A</b>
			<b>Yes</b>	Surface Condition? (G/P)	<b>Good</b>
