Access Compliance Report

Public Rights-of-Way

(Curb Ramps)

Intersection ID: 45310	Main Street: BENFIELD_RD	Cross Street: RIDGE_RD	Location: SW
ADA ID: DFE34B9D1A0D	Ramp Type: Perp	Initial Pass/Fail: Fail	Overall Compliance: No
		Severity Score: 25

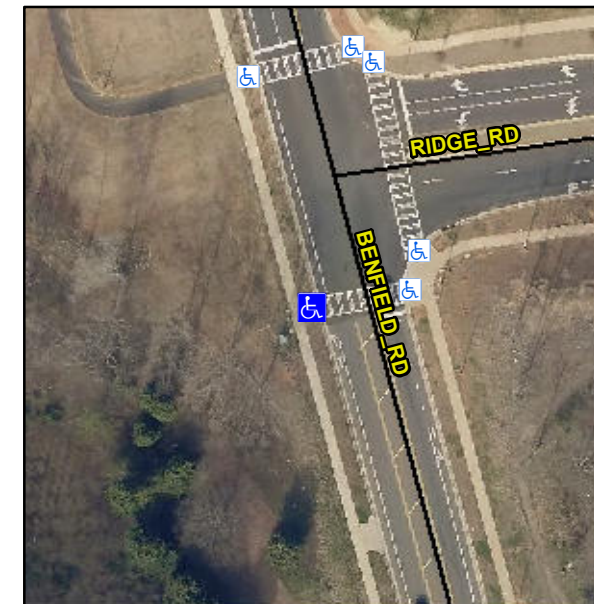
Compliance	Description	Data	Compliance	Description	Data
N/A	Ramp Length (in)	96.0	No	Ramp Slope (%)	13.1
Yes	Ramp Width (in)	71.5	Yes	Ramp XSlope (%)	2.0
N/A	Flare Type LT	N/A	N/A	Flare Type RT	N/A
N/A	Flare Slope LT (%)	N/A	N/A	Flare Slope RT (%)	N/A
N/A	Flare Traversable LT?	N/A	N/A	Flare Traversable RT?	N/A
N/A	Landing Length (in)	N/A	N/A	DWS Provided?	N/A
N/A	Landing Width (in)	N/A	N/A	DWS Contrast?	N/A
N/A	Landing Slope (%)	N/A	N/A	DWS Length (in)	N/A
N/A	Landing X Slope (%)	N/A	N/A	DWS Full Width?	N/A
N/A	Landing Curb? (Y/N)	N/A	N/A	DWS Offset (in)	N/A
N/A	Shared Landing?	N/A			
N/A	Gutter Ponding?	N/A	N/A	Gutter Slope (%)	N/A
N/A	Gutter Lip Ht (in)	N/A	N/A	Gutter X Slope (%)	N/A
N/A	Painted X Walk1?	Yes	N/A	Painted X Walk2?	N/A
	X Walk 1 Direction	To E		X Walk 2 Direction	N/A
N/A	X Walk 1 Width (in)	120.0	N/A	X Walk 2 Width (in)	N/A
	X Walk 1 Slope (%)	2.4		X Walk 2 Slope (%)	N/A
	X Walk 1 X Slope (%)	1.8		X Walk 2 X Slope (%)	N/A

N/A	Ramp inside XWalk1?	Yes	N/A	Ramp inside XWalk2?	N/A
	Road Slope (%)	N/A	N/A	Clear Space?	N/A
	Road X Slope (%)	N/A	N/A	Clear Space to XWalk (in)	N/A
N/A	Any Obstructions?	N/A	N/A	Storm Grate/Utility Hazard?	N/A
	Obstruction Type			Storm Grate/Utility Type	
		N/A			N/A
		Yes		Surface Condition? (G/P)	Good

Possible Solutions:

Remove & Replace Entire Ramp.

R304.2.2

\$ 1850.00
