Access Compliance Report

Public Rights-of-Way

(Curb Ramps)

Intersection ID: 27728	Main Street: BALLANTYNE_COUNTRY_CLUB_DR	Cross Street: COYLE_CR	Location: SE
ADA ID: DFF5AC86FAB6	Ramp Type: Directional	Initial Pass/Fail: Fail	Overall Compliance: No
		Severity Score: 12.5

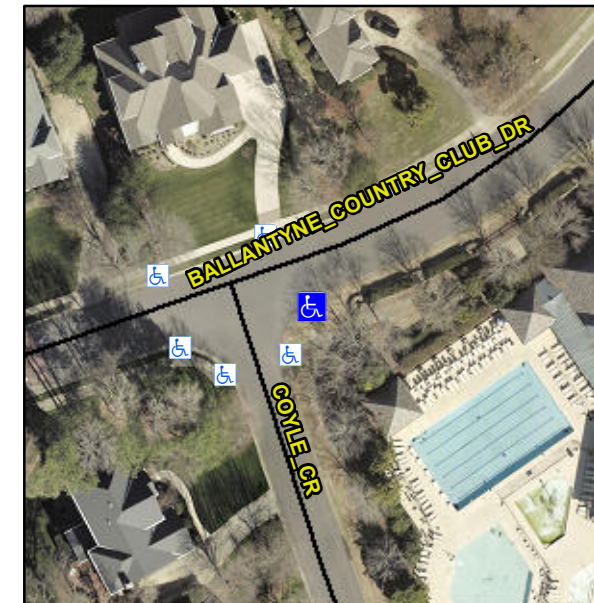
R304.5.3

Compliance	Description	Data	Compliance	Description	Data
N/A	Ramp Length (in)	199.0	N/A	Grade Break?	N/A
Yes	Ramp Width (in)	48.0	N/A	Grade Break Slope (%)	0.0
Yes	Ramp Slope (%)	3.9	N/A	Grade Break XSlope (%)	0.0
No	Ramp XSlope (%)	5.7			
N/A	Flare Type LT	N/A	N/A	Flare Type RT	N/A
N/A	Flare Slope LT (%)	N/A	N/A	Flare Slope RT (%)	0.0
N/A	Flare Traversable LT?	N/A	N/A	Flare Traversable RT?	N/A
N/A	Landing Length (in)	0.0	N/A	DWS Provided?	N/A
N/A	Landing Width (in)	0.0	N/A	DWS Contrast?	N/A
N/A	Landing Slope (%)	0.0	N/A	DWS Length (in)	N/A
N/A	Landing X Slope (%)	0.0	N/A	DWS Full Width?	N/A
N/A	Landing Curb? (Y/N)	N/A	N/A	DWS Offset LT (in)	N/A
N/A	Shared Landing?	N/A	N/A	DWS Offset RT (in)	N/A
N/A	Gutter Ponding?	0.0	N/A	Gutter Slope (%)	N/A
N/A	Gutter Lip Ht (in)	0.0	N/A	Gutter X Slope (%)	N/A
N/A	Painted X Walk1?	No		Road Slope (%)	3.1
	X Walk 1 Direction	To NW		Road X Slope (%)	3.4
	X Walk 1 Width (in)	N/A		Clear Space?	N/A

X Walk 1 Slope (%)	3.1	N/A	Clear Space to XWalk (in)	N/A
	X Walk 1 X Slope (%)	3.4	N/A	Storm Grate/Utility Hazard?	N/A
N/A	Ramp inside XWalk1?	N/A		Storm Grate/Utility Type	
N/A	Any Obstructions?	N/A			N/A
	Obstruction Type		Yes	Surface Condition? (G/P)	Good
			N/A	Curb Slope (%)	16.1

Possible Solutions:

Remove & Replace Entire Ramp.
