Access Compliance Report

Public Rights-of-Way

(Curb Ramps)

Intersection ID: 24356	Main Street: BEVERLY_CREST_BV	Cross Street: CAMAROSS_DR	Location: W
ADA ID: E008EB6B6EFF	Ramp Type: Perp	Initial Pass/Fail: Fail	Overall Compliance: No
			Severity Score: 8.75
Codes/Mitigation Info/Possible Solution		Field Measurements/Component Compliance

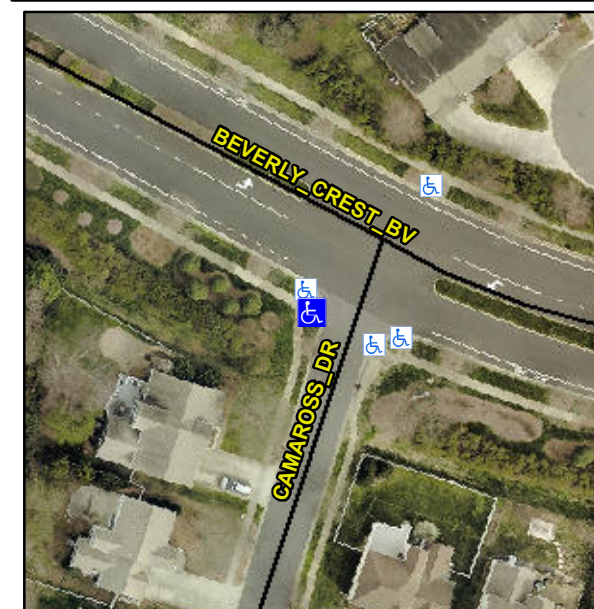
Not Found, R304.5.1

Compliance	Description	Data	Compliance	Description	Data
N/A	Ramp Length (in)	96.0	Yes	Ramp Slope (%)	7.9
No	Ramp Width (in)	45.0	Yes	Ramp XSlope (%)	0.4
N/A	Flare Type LT	N/A	N/A	Flare Type RT	N/A
N/A	Flare Slope LT (%)	N/A	N/A	Flare Slope RT (%)	N/A
N/A	Flare Traversable LT?	N/A	N/A	Flare Traversable RT?	N/A
N/A	Landing Length (in)	N/A	N/A	DWS Provided?	N/A
N/A	Landing Width (in)	N/A	N/A	DWS Contrast?	N/A
N/A	Landing Slope (%)	N/A	N/A	DWS Length (in)	N/A
N/A	Landing X Slope (%)	N/A	N/A	DWS Full Width?	N/A
N/A	Landing Curb? (Y/N)	N/A	N/A	DWS Offset (in)	N/A
N/A	Shared Landing?	N/A			
N/A	Gutter Ponding?	N/A	N/A	Gutter Slope (%)	N/A
N/A	Gutter Lip Ht (in)	N/A	N/A	Gutter X Slope (%)	N/A
N/A	Painted X Walk1?	No	N/A	Painted X Walk2?	N/A
	X Walk 1 Direction	To SE		X Walk 2 Direction	N/A
N/A	X Walk 1 Width (in)	N/A	N/A	X Walk 2 Width (in)	N/A
	X Walk 1 Slope (%)	3.9		X Walk 2 Slope (%)	N/A
	X Walk 1 X Slope (%)	1.9		X Walk 2 X Slope (%)	N/A

N/A	Ramp inside XWalk1?	N/A	N/A	Ramp inside XWalk2?	N/A
	Road Slope (%)	N/A	N/A	Clear Space?	N/A
	Road X Slope (%)	N/A	N/A	Clear Space to XWalk (in)	N/A
N/A	Any Obstructions?	N/A	N/A	Storm Grate/Utility Hazard?	N/A
	Obstruction Type			Storm Grate/Utility Type	
		N/A			N/A
			Yes	Surface Condition? (G/P)	Good

Possible Solutions:

Remove & Replace Entire Ramp.
