Access Compliance Report

Public Rights-of-Way

(Curb Ramps)

Intersection ID: 12076	Main Street: N_CHURCH_ST	Cross Street: W_5TH_ST	Location: N
ADA ID: E00E4F911BFD	Ramp Type: Perp	Initial Pass/Fail: Fail	Overall Compliance: No
			Severity Score: 47.5
Codes/Mitigation Info/Possible Solution		Field Measurements/Component Compliance

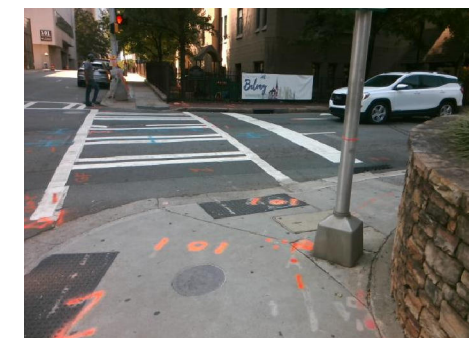
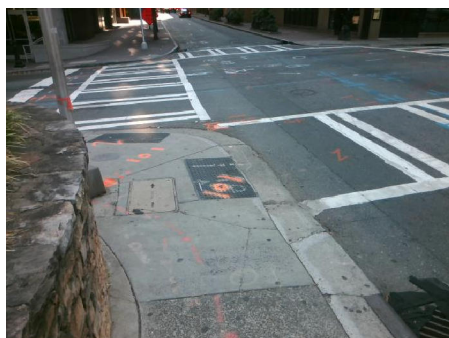
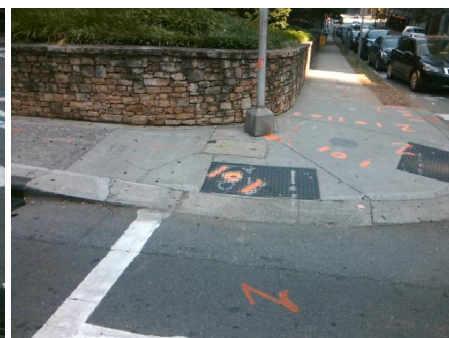
Not Found, R304.5.1, R304.2.2

Compliance	Description	Data	Compliance	Description	Data
N/A	Ramp Length (in)	58.0	No	Ramp Slope (%)	9.8
No	Ramp Width (in)	31.0	Yes	Ramp XSlope (%)	1.0
N/A	Flare Type LT	N/A	N/A	Flare Type RT	N/A
N/A	Flare Slope LT (%)	N/A	N/A	Flare Slope RT (%)	N/A
N/A	Flare Traversable LT?	N/A	N/A	Flare Traversable RT?	N/A
N/A	Landing Length (in)	N/A	N/A	DWS Provided?	N/A
N/A	Landing Width (in)	N/A	N/A	DWS Contrast?	N/A
N/A	Landing Slope (%)	N/A	N/A	DWS Length (in)	N/A
N/A	Landing X Slope (%)	N/A	N/A	DWS Full Width?	N/A
N/A	Landing Curb? (Y/N)	N/A	N/A	DWS Offset (in)	N/A
N/A	Shared Landing?	N/A			
N/A	Gutter Ponding?	N/A	N/A	Gutter Slope (%)	N/A
N/A	Gutter Lip Ht (in)	N/A	N/A	Gutter X Slope (%)	N/A
N/A	Painted X Walk1?	Yes	N/A	Painted X Walk2?	N/A
	X Walk 1 Direction	To SW		X Walk 2 Direction	N/A
N/A	X Walk 1 Width (in)	118.0	N/A	X Walk 2 Width (in)	N/A
	X Walk 1 Slope (%)	6.6		X Walk 2 Slope (%)	N/A
	X Walk 1 X Slope (%)	0.8		X Walk 2 X Slope (%)	N/A

N/A	Ramp inside XWalk1?	Yes	N/A	Ramp inside XWalk2?	N/A
	Road Slope (%)	N/A	N/A	Clear Space?	N/A
	Road X Slope (%)	N/A	N/A	Clear Space to XWalk (in)	N/A
N/A	Any Obstructions?	N/A	N/A	Storm Grate/Utility Hazard?	N/A
	Obstruction Type			Storm Grate/Utility Type	
		N/A			N/A
			Yes	Surface Condition? (G/P)	Good

Possible Solutions:

Remove & Replace Entire Ramp.

Total Cost: \$ 1850.00
