## Access Compliance Report Public Rights-of-Way (Curb Ramps)

Intersection ID: 10022367Main Street: CAMFIELD\_STCross Street: N/ALocation:NEADA ID: E00F21D90DCDRamp Type: PerpDiagInitial Pass/Fail: FailOverall Compliance: NoSeverity Score: 21.25

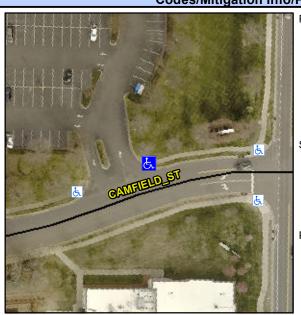
R304.5.1, R304.5.3

Compliance Description D		Data	Compl	iance Description	Data
N/A	Ramp Length (in)	92.0	Yes	Ramp Slope (%)	8.0
No	Ramp Width (in)	41.0	No	Ramp XSlope (%)	6.0
N/A	Flare Type LT	N/A	N/A	Flare Type RT	N/A
N/A	Flare Slope LT (%)	N/A	N/A	Flare Slope RT (%)	N/A
N/A	Flare Traversable LT?	N/A	N/A	Flare Traversable RT?	N/A
N/A	Landing Length (in)	N/A	N/A	DWS Provided?	N/A
N/A	Landing Width (in)	N/A	N/A	DWS Contrast?	N/A
N/A	Landing Slope (%)	N/A	N/A	DWS Length (in)	N/A
N/A	Landing X Slope (%)	N/A	N/A	DWS Full Width?	N/A
N/A	Landing Curb? (Y/N)	N/A	N/A	DWS Offset (in)	N/A
N/A	Shared Landing?	N/A			
N/A	Gutter Ponding?	N/A	N/A	Gutter Slope (%)	N/A
N/A	Gutter Lip Ht (in)	N/A	N/A	Gutter X Slope (%)	N/A
N/A	Painted X Walk1?	No	N/A	Painted X Walk2?	No
	X Walk 1 Direction	To W		X Walk 2 Direction	To S
N/A	X Walk 1 Width (in)	N/A	N/A	X Walk 2 Width (in)	N/A
	X Walk 1 Slope (%)	2.1		X Walk 2 Slope (%)	6.5
	X Walk 1 X Slope (%)	6.6		X Walk 2 X Slope (%)	0.4

N/A	Ramp inside XWalk1?	N/A	N/A	Ramp inside XWalk2?	N/A
	Road Slope (%)	5.9	N/A	Clear Space?	N/A
	Road X Slope (%)	1.9	N/A	Clear Space to XWalk (in)	N/A
N/A	Any Obstructions?	N/A	N/A	Storm Grate/Utility Hazard?	N/A
	Obstruction Type		l	Storm Grate/Utility Type	
		N/A			N/A
			Yes	Surface Condition? (G/P)	Good

Remove & Replace Curb Ramp With Two New Directional Ramps or Equivalent.

Total Cost: \$ 3200.00
