Access Compliance Report

Public Rights-of-Way

(Curb Ramps)

Intersection ID: 17815	Main Street: IDLEWILD_RD	Cross Street: VESTAL_PL	Location: SW
ADA ID: E01089F31C45	Ramp Type: PerpDiag	Initial Pass/Fail: Fail	Overall Compliance: No
Severity Score: 12.5			
Codes/Mitigation Info/Possible Solution		Field Measurements/Component Compliance

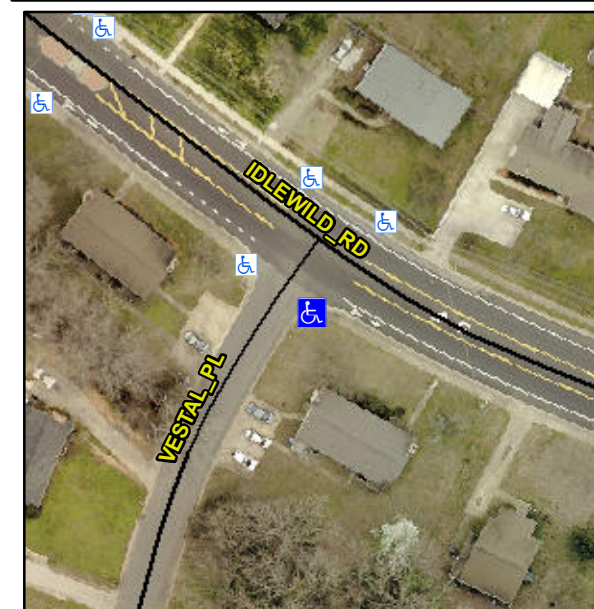
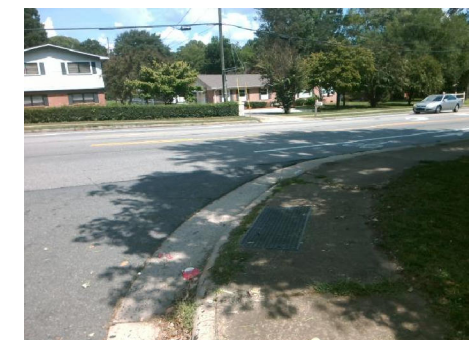
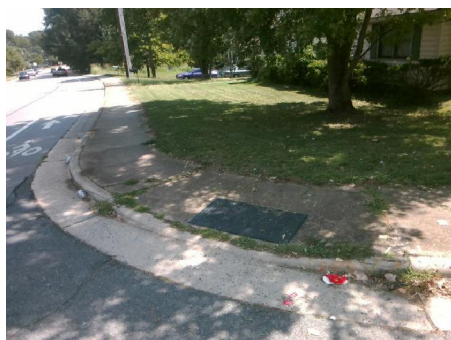
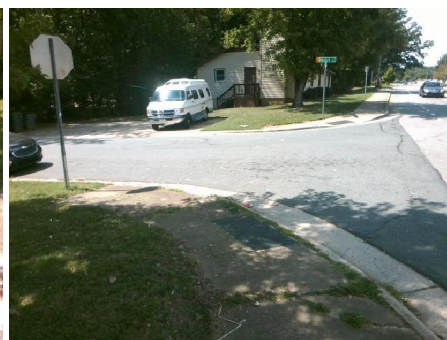
Not Found, R304.2.2

Compliance	Description	Data	Compliance	Description	Data
N/A	Ramp Length (in)	62.0	No	Ramp Slope (%)	9.2
Yes	Ramp Width (in)	48.0	Yes	Ramp XSlope (%)	1.9
N/A	Flare Type LT	N/A	N/A	Flare Type RT	N/A
N/A	Flare Slope LT (%)	N/A	N/A	Flare Slope RT (%)	N/A
N/A	Flare Traversable LT?	N/A	N/A	Flare Traversable RT?	N/A
N/A	Landing Length (in)	N/A	N/A	DWS Provided?	N/A
N/A	Landing Width (in)	N/A	N/A	DWS Contrast?	N/A
N/A	Landing Slope (%)	N/A	N/A	DWS Length (in)	N/A
N/A	Landing X Slope (%)	N/A	N/A	DWS Full Width?	N/A
N/A	Landing Curb? (Y/N)	N/A	N/A	DWS Offset (in)	N/A
N/A	Shared Landing?	N/A			
N/A	Gutter Ponding?	N/A	N/A	Gutter Slope (%)	N/A
N/A	Gutter Lip Ht (in)	N/A	N/A	Gutter X Slope (%)	N/A
N/A	Painted X Walk1?	No	N/A	Painted X Walk2?	No
	X Walk 1 Direction	To NE		X Walk 2 Direction	To NW
N/A	X Walk 1 Width (in)	N/A	N/A	X Walk 2 Width (in)	N/A
	X Walk 1 Slope (%)	6.3		X Walk 2 Slope (%)	9.4
	X Walk 1 X Slope (%)	4.3		X Walk 2 X Slope (%)	2.9

N/A	Ramp inside XWalk1?	N/A	N/A	Ramp inside XWalk2?	N/A
	Road Slope (%)	0.3	N/A	Clear Space?	N/A
	Road X Slope (%)	9.0	N/A	Clear Space to XWalk (in)	N/A
N/A	Any Obstructions?	N/A	N/A	Storm Grate/Utility Hazard?	N/A
	Obstruction Type			Storm Grate/Utility Type	
		N/A			N/A
		Yes		Surface Condition? (G/P)	Good

Remove & Replace Curb Ramp With Two New Directional Ramps or Equivalent.

Total Cost: \$ 3200.00
