# Access Compliance Report

## Public Rights-of-Way

### (Curb Ramps)

| Intersection ID: 10020394 | Main Street: BALLANTYNE_CROSSING_AV | Cross Street: N/A | Location: NW |

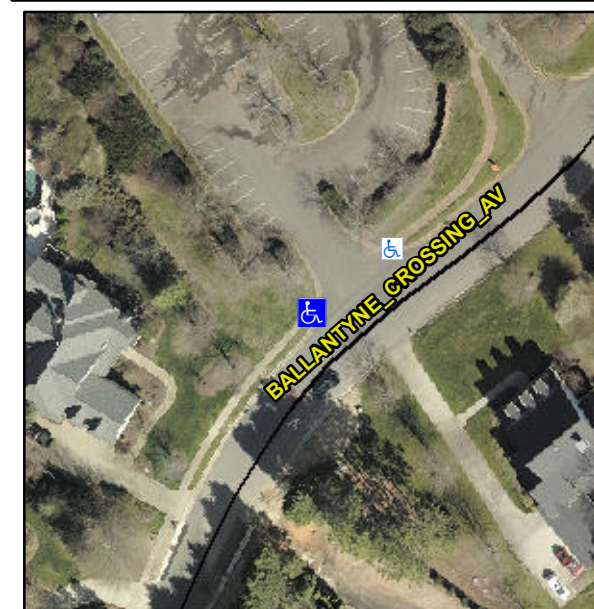
| ADA ID: E023E7AD885B | Ramp Type: PerpDiag | Initial Pass/Fail: Fail | Overall Compliance: No |
| Severity Score: 33.75 | | | |

**Not Found, R304.5.1, R304.5.3**

| Compliance | Description | Data | Compliance | Description | Data |
|---|---|---|---|---|---|
| N/A | Ramp Length (in) | 95.0 | Yes | Ramp Slope (%) | 5.9 |
| No | Ramp Width (in) | 45.0 | No | Ramp XSlope (%) | 9.9 |

**Remove & Replace Curb Ramp With Two New Directional Ramps or Equivalent.**

Total Cost: \$ 3200.00
