Access Compliance Report

Public Rights-of-Way

(Curb Ramps)

Intersection ID: 18387	Main Street: BURTONWOOD_CR	Cross Street: MONROE_RD	Location: NW
ADA ID: E02BB2079D87	Ramp Type: PerpDiag	Initial Pass/Fail: Fail	Overall Compliance: No
Codes/Mitigation Info/Possible Solution		Field Measurements/Component Compliance

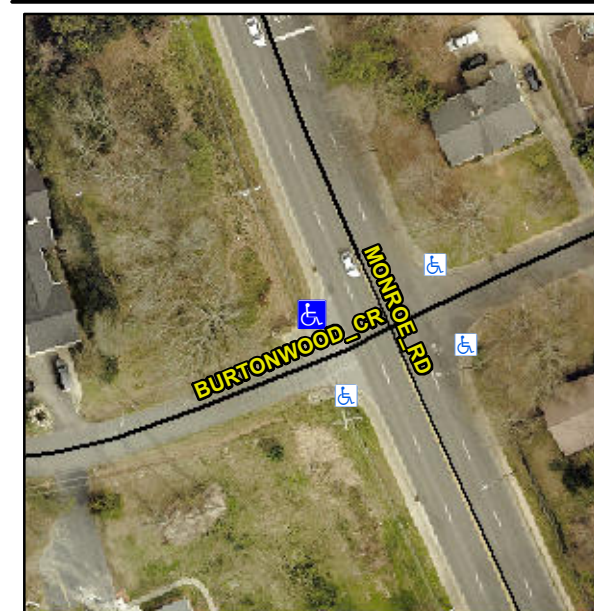
Not Found, R304.2.2, R304.5.3

Compliance	Description	Data	Compliance	Description	Data
N/A	Ramp Length (in)	60.0	No	Ramp Slope (%)	11.8
Yes	Ramp Width (in)	48.0	No	Ramp XSlope (%)	4.9
N/A	Flare Type LT	N/A	N/A	Flare Type RT	N/A
N/A	Flare Slope LT (%)	N/A	N/A	Flare Slope RT (%)	N/A
N/A	Flare Traversable LT?	N/A	N/A	Flare Traversable RT?	N/A
N/A	Landing Length (in)	N/A	N/A	DWS Provided?	N/A
N/A	Landing Width (in)	N/A	N/A	DWS Contrast?	N/A
N/A	Landing Slope (%)	N/A	N/A	DWS Length (in)	N/A
N/A	Landing X Slope (%)	N/A	N/A	DWS Full Width?	N/A
N/A	Landing Curb? (Y/N)	N/A	N/A	DWS Offset (in)	N/A
N/A	Shared Landing?	N/A			
N/A	Gutter Ponding?	N/A	N/A	Gutter Slope (%)	N/A
N/A	Gutter Lip Ht (in)	N/A	N/A	Gutter X Slope (%)	N/A
N/A	Painted X Walk1?	No	N/A	Painted X Walk2?	No
	X Walk 1 Direction	To S		X Walk 2 Direction	To E
N/A	X Walk 1 Width (in)	N/A	N/A	X Walk 2 Width (in)	N/A
	X Walk 1 Slope (%)	1.2		X Walk 2 Slope (%)	3.6
	X Walk 1 X Slope (%)	3.4		X Walk 2 X Slope (%)	3.1

N/A	Ramp inside XWalk1?	N/A	N/A	Ramp inside XWalk2?	N/A
	Road Slope (%)	3.8	N/A	Clear Space?	N/A
	Road X Slope (%)	2.3	N/A	Clear Space to XWalk (in)	N/A
N/A	Any Obstructions?	N/A	N/A	Storm Grate/Utility Hazard?	N/A
	Obstruction Type			Storm Grate/Utility Type	
		N/A			N/A
			Yes	Surface Condition? (G/P)	Good

Remove & Replace Curb Ramp With Two New Directional Ramps or Equivalent.
